Opuscula

Annual of the Swedish Institutes at Athens and Rome

The cisterns of the Bisti promontory at Hermione

With a preliminary description of the Roman aqueduct

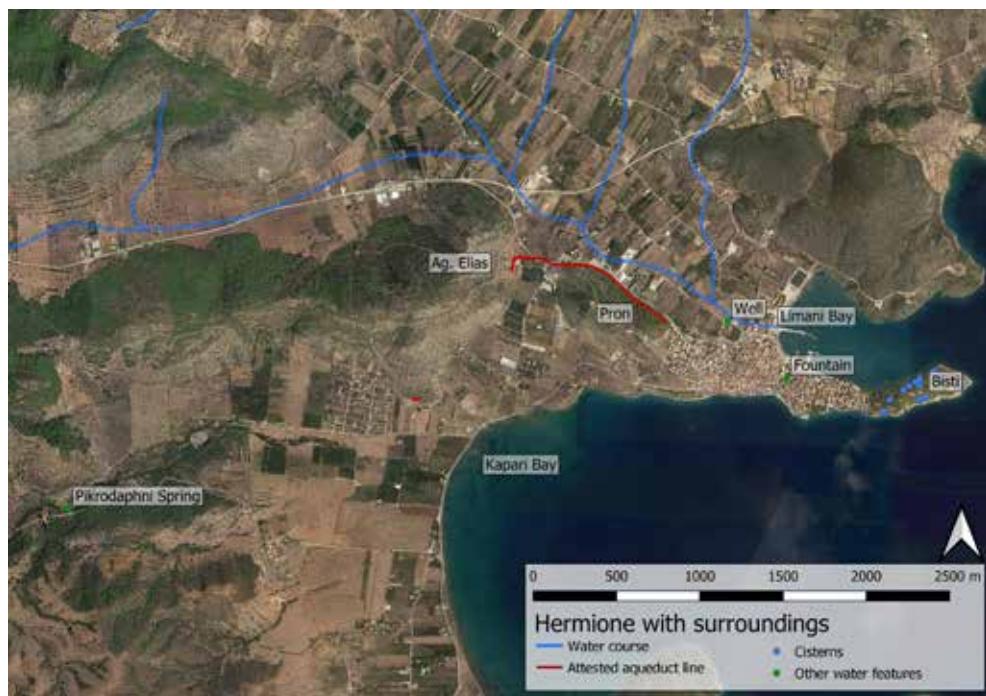
Fig. 1. Map over the area of Hermione with attested sections of the aqueduct (red), the local watercourse (blue), cisterns (blue circles), and other selected water installations (green circles). Illustration by Patrik Klingborg, basemap by Google, ©CNES/Airbus, European Space Imaging, Landsat/Copernicus, Maxar Technologies, Map data 2021.

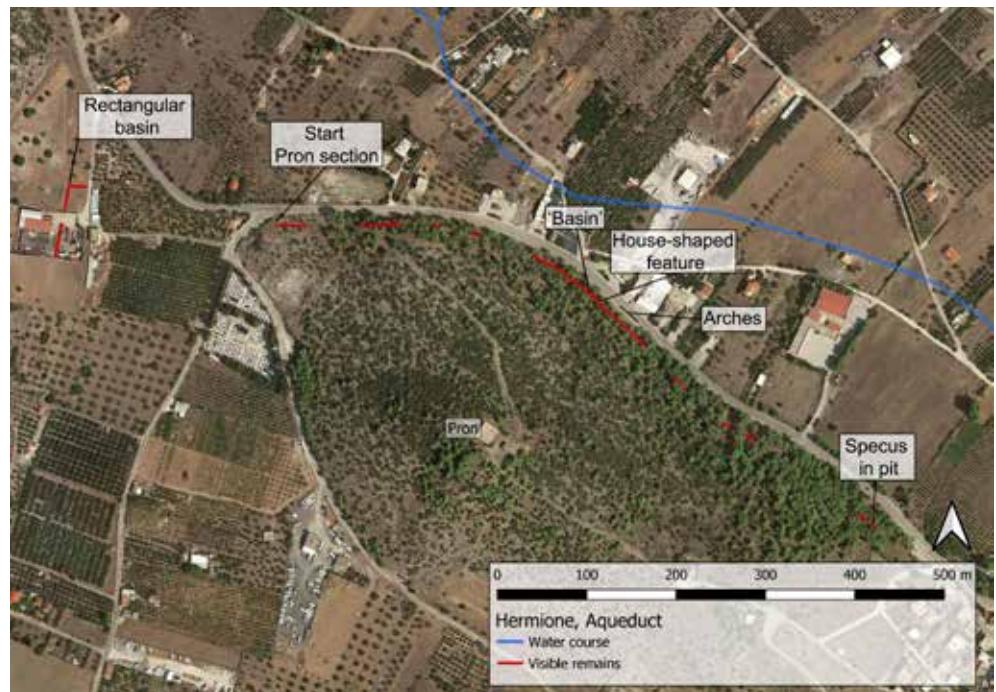
Fig. 2a. Detail of the aqueduct along Pron Hill. Illustration by Patrik Klingborg, basemap by Google, ©CNES/Airbus, European Space Imaging, Maxar Technologies, Map data 2021.

Another 15 m east from this feature the solid wall of the aqueduct is pierced by five low arches (Figs. 2a, c). These have been noted by several previous scholars.³⁰ The arches all seem to have rested on a solid continuous wall. The first arch from the west is the best preserved. It measures 1.50 m across at the base with an estimated height of 0.75 m. Practically all of the voussoir stones are preserved. On the inside of the arch the imprints in the mortar of at least four wooden planks forming the formwork used to create the arch are visible (Fig. 2d).³¹ At the east base of the arch there is a wall abutting the foundation on the downhill side. The second arch is in a comparably poor state with most of the voussoir stones gone. The original diameter can be estimated to have been about 1.50 m, the height 1.00 m. The third, middle, arch has collapsed completely, leaving a gap in the aqueduct. The fourth arch still remains with a width of 1.70 m and height of 0.90 m. Notably, the outer layer of stones for the arch has been removed, leaving only an imprint. Between the fourth and fifth arch the imprint in the lining of a 0.15 m wide supporting wall can be seen. The dimensions of the fifth arch are similar to those of the fourth, and again the stones of the arch have been removed. A wider support wall, 0.55 m high and 0.55 m wide, abutted the aqueduct just to the east of the fifth arch.

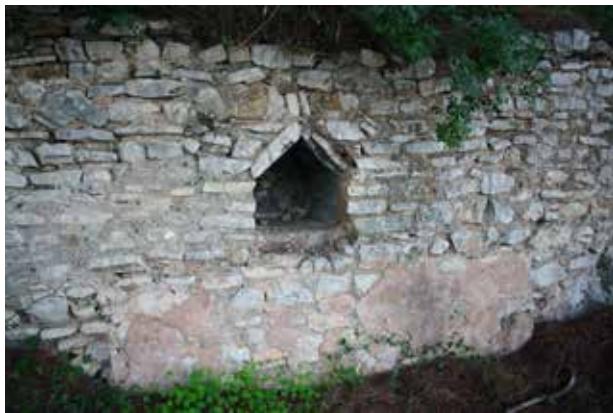
Fig. 2b. House-shaped feature in the aqueduct. Note the pink plaster covering the aqueduct. Photograph by Patrik Klingborg.

the lower area between the Aghios Elias and Pron Hill where the watercourse once flowed, presumably using arcades, none of which are preserved today. According to Gkatsos they could be observed to a height of four metres in 1980.²⁴ They are also visible in a photograph in a book about local herbs published in 1988.²⁵ From the west foot of the Pron the aqueduct clings to the north slope just above the modern road. The first preserved part at the west end of the Pron, located 235 m from the rectangular basin, is formed by a solid wall 2.25 m high and 0.95 m wide (Fig. 2a). As with the rest of the aqueduct, this section is constructed in a rubble stone masonry formed by small roughly rectangular stones bound together with a generous amount of mortar in between, often more than 0.03 m, sometimes up to 0.10 m. Almost no materials of terracotta were observed in any of the preserved sections, indicating that this was used only sparingly (Figs. 2b–c).

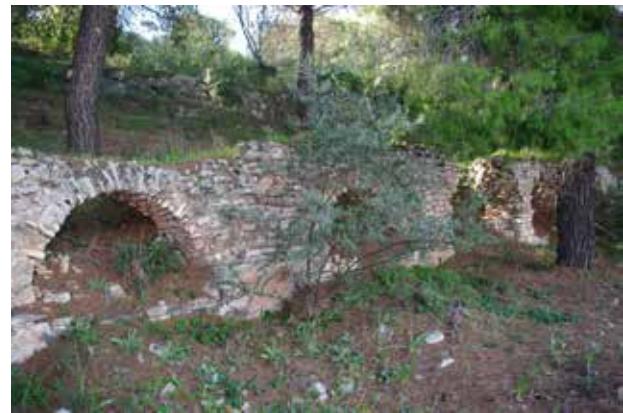
Fig. 2c. The section with the arches. Photograph by Patrik Klingborg.

While these arches would allow humans and animals to pass through, albeit not very comfortably, this was probably not their primary function. Similarly, the reduction in material used was rather minimal. Instead it seems likely that the arches were intended to allow rain water, perhaps even winter torrents (known as *χαράδραι*), to pass through. This interpretation is corroborated by the three walls abutting the aqueduct on the downhill side in this area, indicating that the structure was under considerable stress.

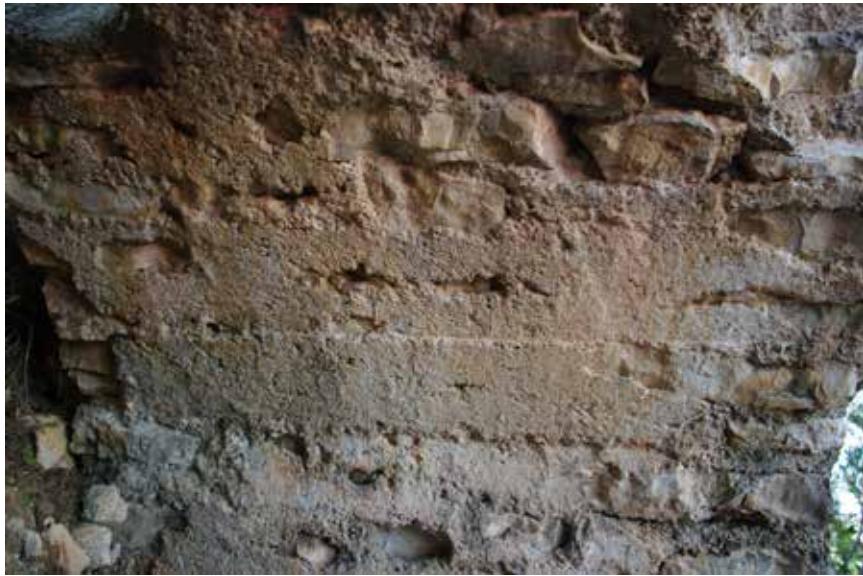
Fig. 2d. Imprints in the mortar of wooden moulds from the construction of the first arch from the west. Photograph by Patrik Klingborg

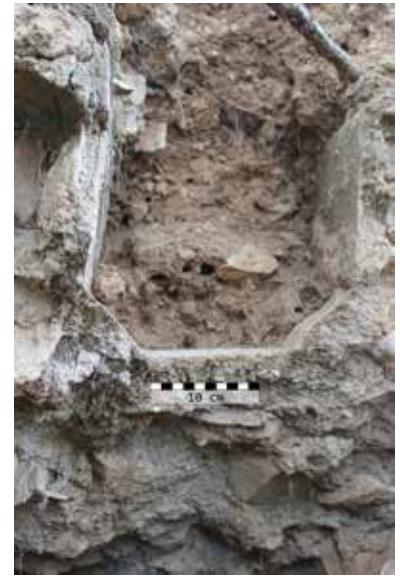
Fig. 2e. Specus of the aqueduct. Photograph by Patrik Klingborg

After the arches the aqueduct continues until, at 660 m from the rectangular basin, another wall abuts the aqueduct on the downhill side. This wall is 1.20 m long and 0.40 m high. At about 2.30 m to the east from this supporting wall a weeping hole measuring 0.20 × 0.30 m is found at the top of the aqueduct. After this point the aqueduct is often completely hidden underground and visible only intermittently further to the east. The last location where the aqueduct can be securely identified is located just over 1 km east (following the course of the structure) from the rectangular basin. Here a pit exposes the best-preserved section of the *specus* visible today (Fig. 2e).

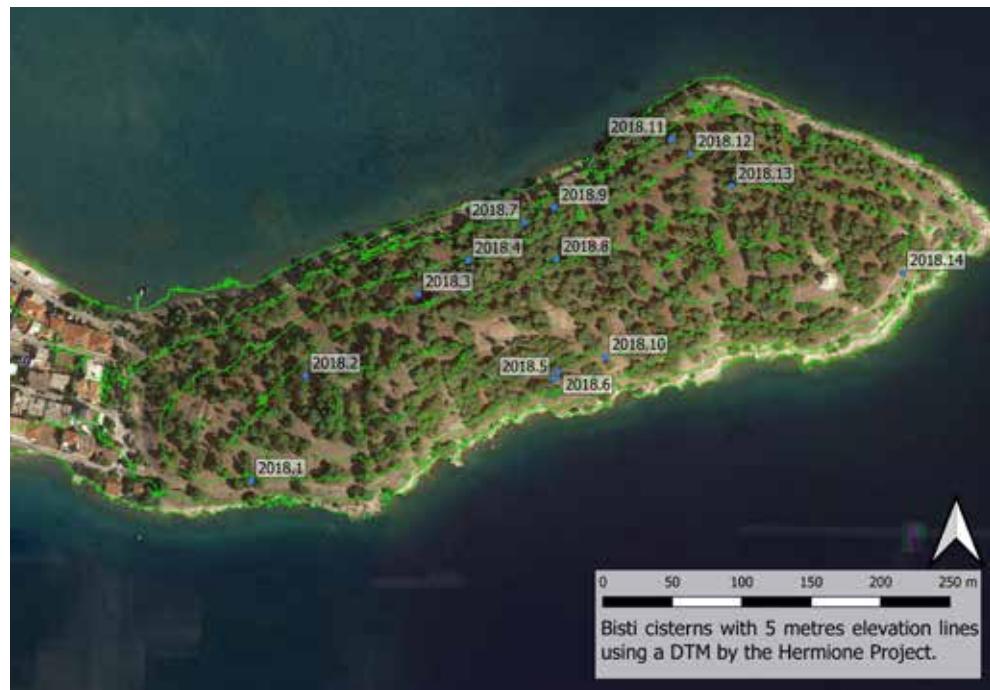
Fig. 3. The Bisti promontory with cisterns indicated. Illustration by Patrik Klingborg, basemap by Google, ©CNES/Airbus, European Space Imaging, Maxar Technologies, Map data 2021.

The fieldwork within the framework of the Hermione project recorded 14 potential cisterns during the 2018 season (Fig. 3). Of these, the nature of two (2018.6 and 2018.14) must be considered uncertain. One cistern (2018.12) appears to have been left unfinished in antiquity based on the lack of a lining. It is likely that a considerable number of cisterns are completely filled in and not visible today. This assumption is corroborated by the unknown cistern marked on the map by Frickenhaus and Müller (*Gerding 2021, fig. 2*) as well as a preliminary analysis of the results from Derek Pitman’s magnetometry survey in 2018.⁴⁴ Scholars have also noted further ancient cisterns in the modern city of Hermione, but without providing specific information.⁴⁵ However, at least two cisterns of unknown date can be seen in the city today. One is located in an abandoned plot c. 85 m east of the Taxiarches Church. This cistern is completely subterranean and the visible section pithos-shaped, possibly indicating a Roman or even considerably later date. Another cistern is located c. 55 m north-west of the same church. This cistern probably post-dates antiquity by a considerable margin considering its shallow depth (probably no more than 2.50 m) and because the mouth is situated 0.50 m above the modern street level.

Notably, the cisterns are unevenly located on the Bisti (Fig. 3). Eight (2018.3, 2018.4, 2018.7, 2018.8, 2018.9, 2018.11, 2018.12 and 2018.13) are found on the north side, only one (2018.2) on the ridge, and five on the south side (2018.1, 2018.5, 2018.6, 2018.10, and 2018.14). Eight of the cisterns (2018.3, 2018.4, 2018.5, 2018.6, 2018.7, 2018.8, 2018.9, and 2018.10) are located in the central area. Only two (2018.1 and 2018.2) are located in the western third of the promontory and four (2018.11, 2018.12, 2018.13, and 2018.14) on the eastern third. Of the cisterns almost half (6 out of 14) are located between 20 and 25 m from the water-line (2018.7, 2018.9, and 2018.11 on the north side, 2018.1, 2018.5, and 2018.10 on the south side).

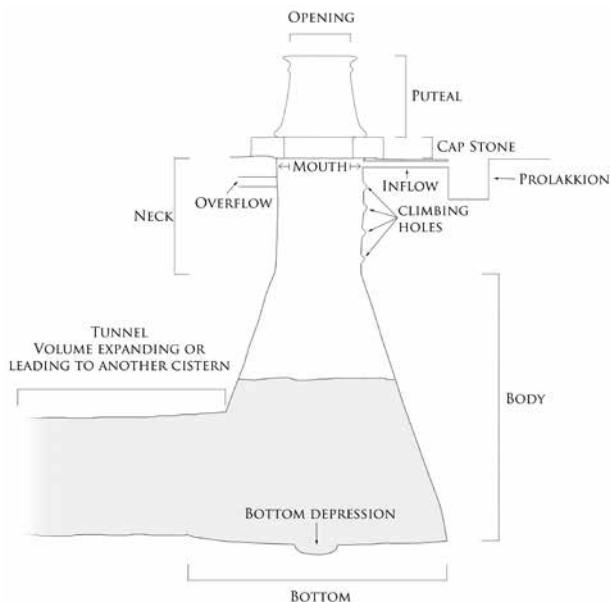
Fig. 4. Cistern section, with terminology and features indicated. Illustration by Patrik Klingborg, previously published in Klingborg 2017, fig. 1.

The cisterns on the Bisti promontory are described below, from west to east. In the following discussion the term *body* designates the expanding chamber in the lower section of a cistern (Fig. 4). Above this a considerably narrower section, the *neck*, is commonly found. The top of the neck, i.e. the point where the underground section of the cistern begins, is called the *mouth*. The original mouth may have been considerably higher up than today if the ground has been cut down after its construction, or later after its abandonment. Often one or more blocks, forming a *capstone*, covered the mouth in order to protect this vulnerable section from wear. The capstone could, in turn, be crowned by a *puteal* (well-head).⁴⁸ The term *opening* designates the narrowest point through which the cistern could be accessed. In antiquity the size of the opening would usually be limited by the *puteal* or capstone. Finally, *lining* denotes the material used to make the cisterns waterproof in order to avoid otherwise common terms, e.g. cement, mortar, and plaster, suggesting specific manufacturing processes and composition.⁴⁹

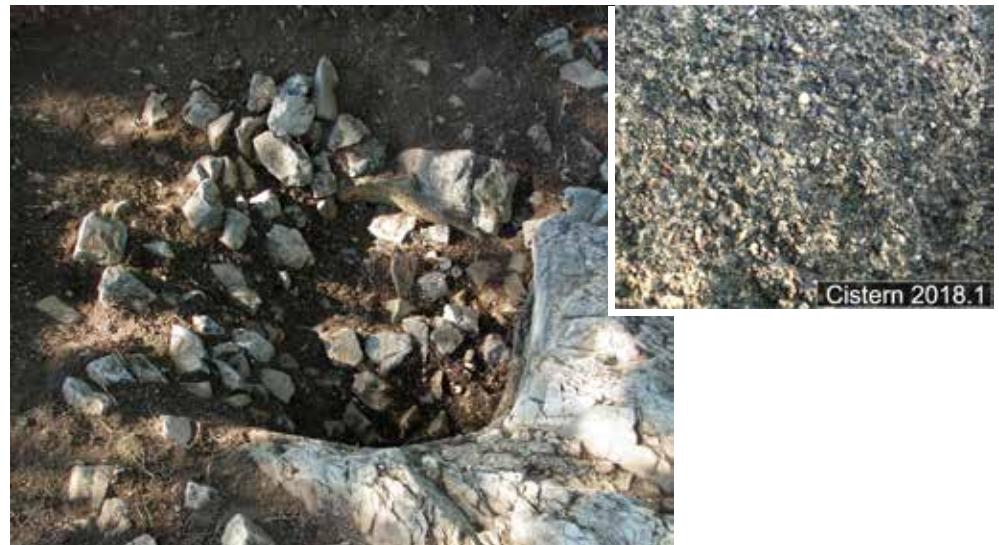
Fig. 5. Cistern 2018.1, mouth, with a diameter of 90 cm. With detail of lining. Photographs by Patrik Klingborg

The westernmost cistern is found 18 m north of the south coast and 95 m from the modern south entrance to the Bisti (Fig. 5).

The cistern is filled almost to the top with modern refuse, stones, and organic material. Consequently, no more than 35 cm of the neck is visible. The mouth is formed by an irregular circle, 90 cm in diameter east–west where the full circumference can be seen. The irregularity of the mouth suggests that its ancient counterpart was higher up. The loss of the original neck and mouth is also supported by the observation that the neck seems to expand into the body just under the modern rubble. The lining in the cistern is a pale yellow, tending towards white where recently fractured. Small pebbles 0.1–0.2 cm in diameter are common in the lining. The thickness of the lining is 2–3 cm in most areas, but some sections are as thin as 1.5 cm. In a sharp bend the lining is up to 5.5 cm thick.

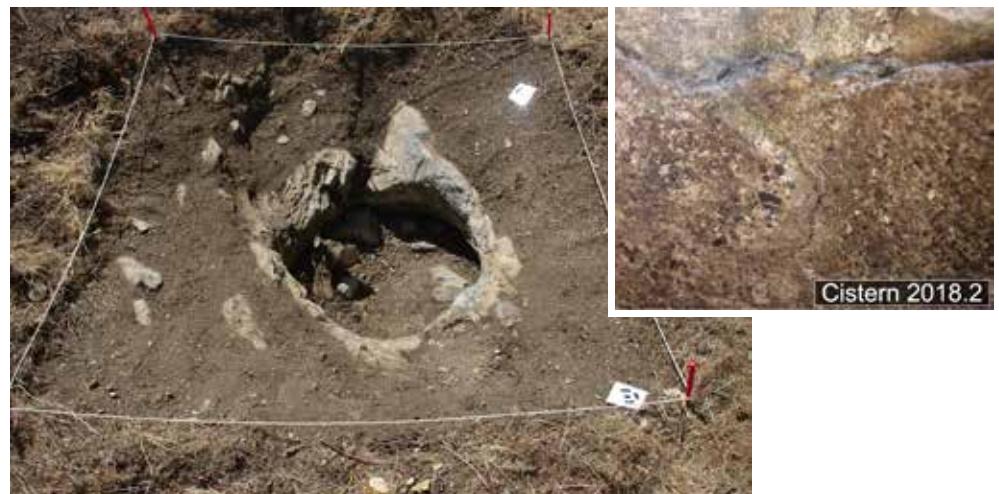
Fig. 6. Cistern 2018.2, mouth, with a diameter of 90 cm. With detail of lining. Photographs by Patrik Klingborg

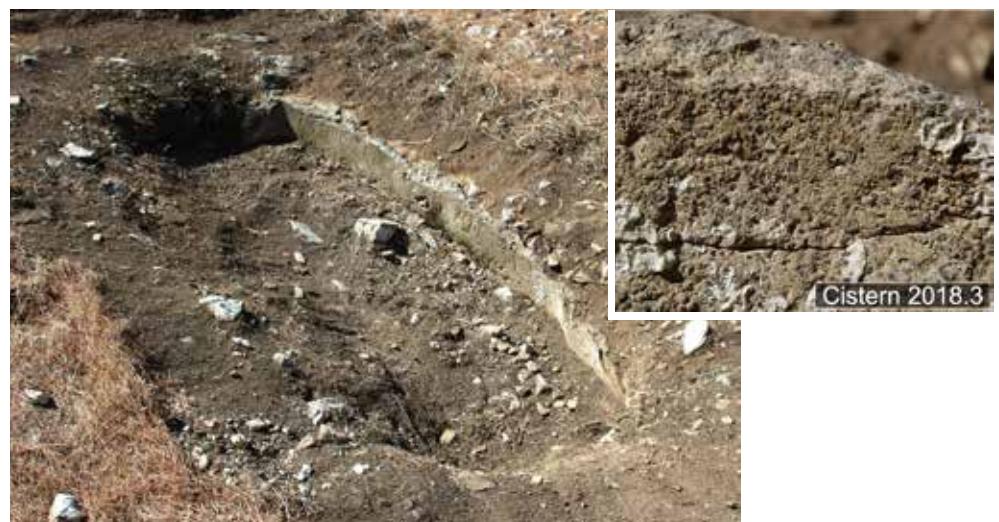
Fig. 7. Cistern 2018.3, general view. With detail of lining. Photographs by Patrik Klingborg

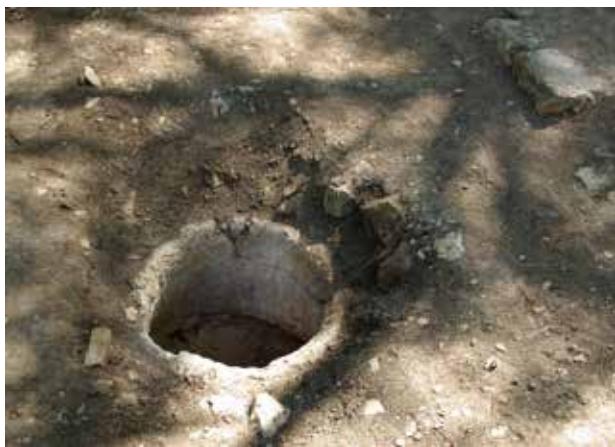
Fig. 8. Cistern 2018.4, surface view showing the 53 cm wide opening and the repaired section. Photograph by Patrik Klingborg.

Another cistern is located 45 m south of the northern shore of the Bisti and 50 m north-west of the temple foundations (Fig. 8). Unlike the previous cisterns this one remained unfilled to a level of 150 cm below the surface, ensuring that the capstone, neck, and upper body were visible. About 90 cm to the south of the cistern at least two stones seemed to form a wall running east–west with two further stones possibly belonging to the same stretch.

The opening of the cistern is formed by a capstone cut from one single block. While the outer dimensions of this block are unknown, the opening is circular, 50 cm deep, and slightly funnel shaped with an upper diameter of 53 cm and lower diameter of 65 cm. On the inside a thin layer may be the remains of lining or incrustations. At the south-east side

a rectangular and slightly concave block, 40 cm long and 12 cm high, is carefully inset in the capstone, indicating that this had been damaged and repaired at some point (Fig. 8, top right of the cistern opening). Across from the repaired section, in the north-west side of the capstone, a depression may indicate the location of the inflow channel. A possible cutting for a lead clamp can be seen on the west surface of the capstone. Moreover, on the south side of the capstone three stones suggest that the mouth was raised during the cistern's period of use as a water source (Fig. 8).

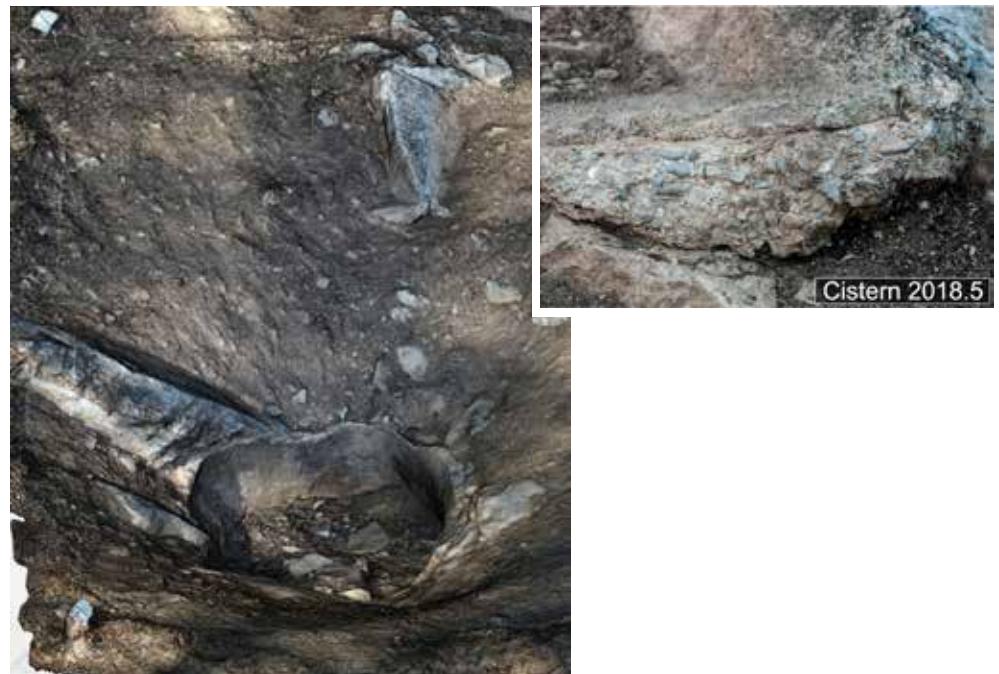
Fig. 9. Photogrammetry model of cistern 2018.5, mouth, with a diameter of 90 cm and the lined section in the top right corner. Illustration by Hanna Häkansson. With section of the lined feature. Photograph by Patrik Klingborg.

On the other side of the Bisti a cistern is situated 35 m south of the central part of the edge of the temple foundations, and 25 m north of the south coast (Fig. 9). It was filled almost to the top with modern refuse and pine needles.

The preserved mouth of the cistern is round with a diameter of 90 cm. Below the top of the mouth the neck is clear of refuse for 35 cm. Another 10 cm of depth is visible under the rubble fill. Possibly the cistern begins to expand into the body at this point. On the north side of the mouth and neck a small outwards bulge is found, continuing from the preserved top to the visible bottom. This may indicate where the inflow was originally located. The lining is a pale yellow in colour and composed of a cruder inner and finer outer layer. Together they form a 1–9 cm thick surface, with the thickest areas being found in a “corner”. The inclusions in the cruder inner layer are up to 1 cm in diameter.

About 1 m above the cistern a single lined stone block was found (Fig. 9, top right). It was unclear whether the block was loose or part of the bedrock. As in the cistern below, the lining on the block was executed in two layers. The inner was cruder and up to 5.5 cm thick, the outer considerably finer and only 0.7–1 cm thick. The outer layer was, however, not as smooth as that in many of the other cisterns. Near the bottom the lining makes a sharp turn from a sloping direction into a horizontal surface. It is unclear what this feature was. It may be part of the original neck of the cistern, in which case the horizontal surface probably formed a climbing hole. Such a loose climbing hole is known from a collapsed cistern at Agrileza in Attica.⁵¹ Another possibility is that it was part of a water channel leading to cistern 2018.5 from above, possibly cistern 2018.6. Finally, it could be part of a *prolakkion*, i.e. a water basin located before the cistern and used to remove silt and other impurities (Fig. 4).⁵²

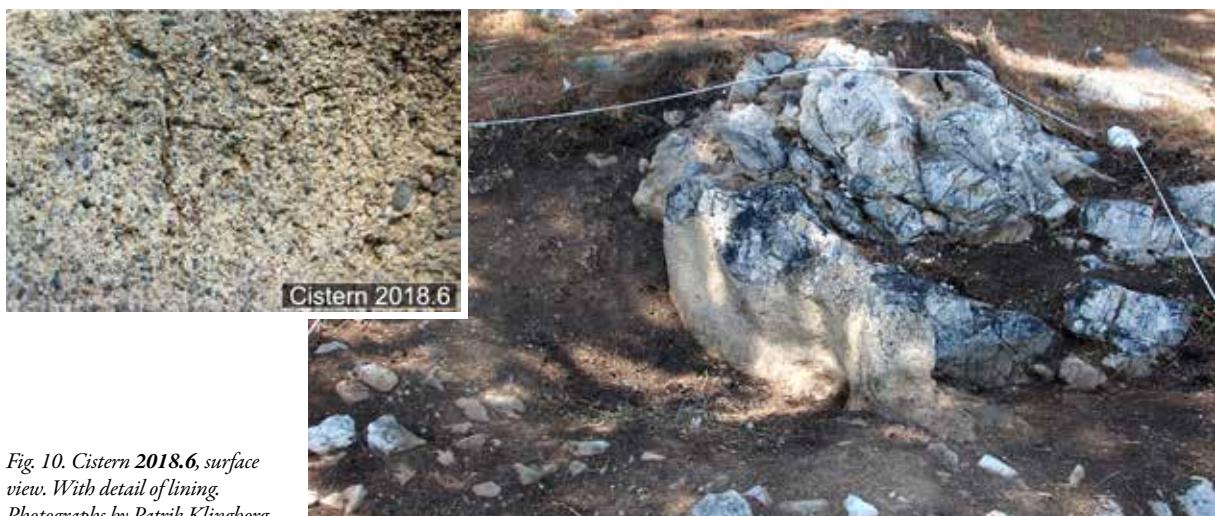
Fig. 10. Cistern 2018.6, surface view. With detail of lining. Photographs by Patrik Klingborg.

At present there is not enough evidence to identify this installation as a cistern with reasonable certainty. It is equally possible that it was a *prolakkion* for cistern 2018.5. The connection between cistern 2018.5 and 2018.6 is strengthened by similarity in lining and the presence of the lined feature situated between them.

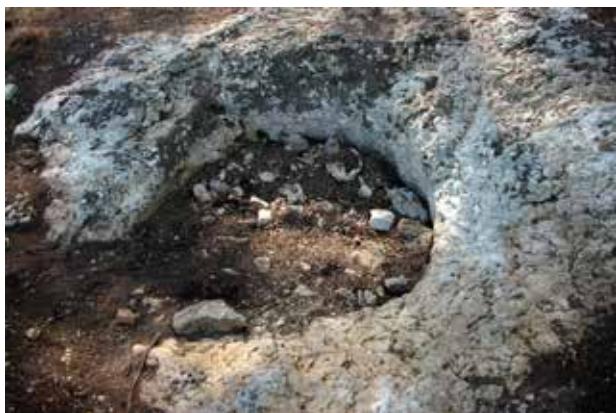
Fig. 11. Cistern 2018.7, mouth, with a diameter of 110–115 cm. Photograph by Patrik Klingborg.

On the north side of the Bisti, 23 m from the northern shore and 65 m north of the temple the round mouth of a cistern is found (Fig. 11). Almost the whole circumference is preserved, measuring 110 cm east–west and 115 cm north–south. There

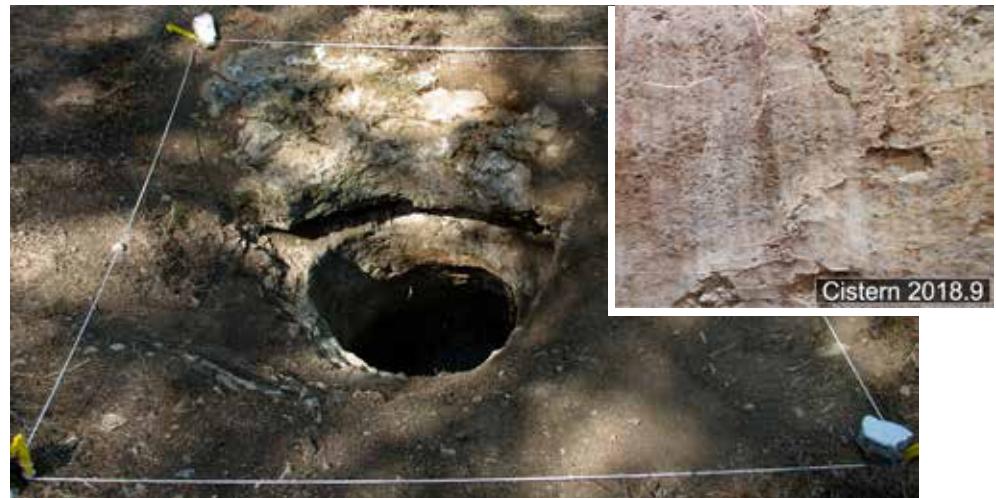
Fig. 12. Cistern 2018.9, mouth, with a diameter of 76–79 cm. With detail of lining. Photographs by Patrik Klingborg.

The next cistern is found about 15 m north-east from cistern 2018.7 and 27 m to the south of the north coast. Today the mouth, neck, and upper part of the body are clearly visible to a depth of 190 cm and in a good state of preservation

(Fig. 12). The fill is a mix of rocks, organic material, and modern refuse.

The preserved mouth of the cistern is almost circular, measuring 76 cm east–west and 79 cm north–south. The maximum depth of the neck is 70 cm, but the upper 30 cm is only preserved on the west side. Below this there is a 20 cm long crack under which the full circumference of the neck is preserved, although less well on the south side, before expanding into the body. Presumably a natural crack ran through the bedrock forcing the neck to be constructed rather than cut on the south, east, and north side. Notably a large fragment of a ceramic vessel, possibly a body sherd from an amphora, was visible in the soil and stone wall above the preserved neck on the south side. It is possible that this belongs to the material used when building the upper section of the neck.

With the exception of the upper neck above the crack, the lining of the cistern is 3 cm thick and a fairly uniform pale yellow colour. Only a small number of small pebble inclusions are visible. Above the crack the lining is very thin, no more than a few millimetres.

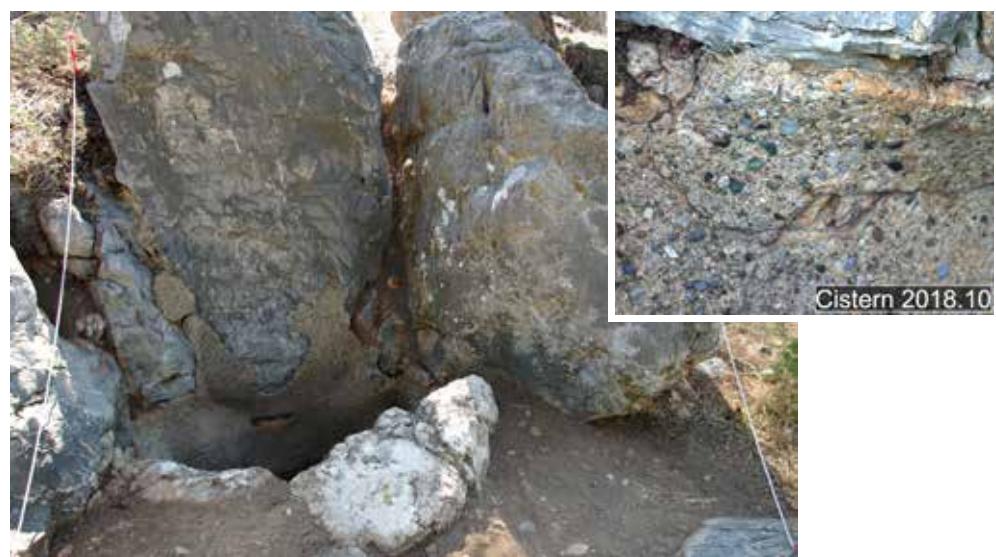
Figs. 13a–b. Cistern 2018.10, a) upper section and opening, with the mouth measuring 75 × 120 cm, b) neck masonry. With detail of lining. Photographs by Patrik Klingborg.

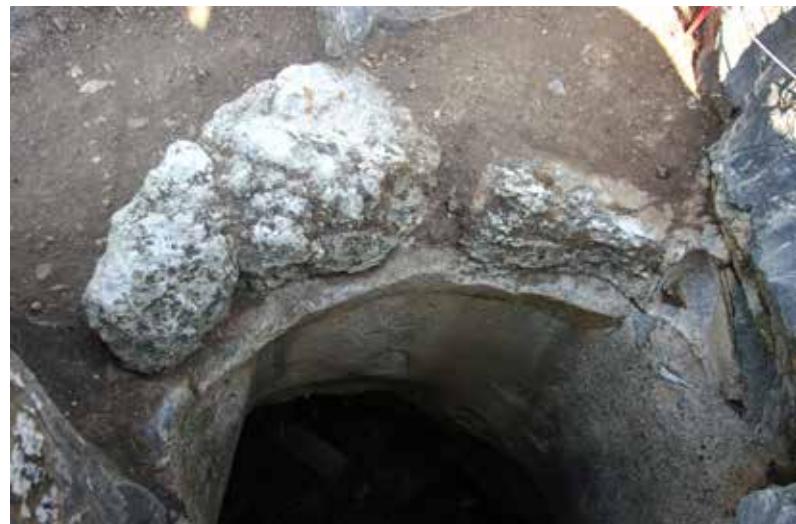
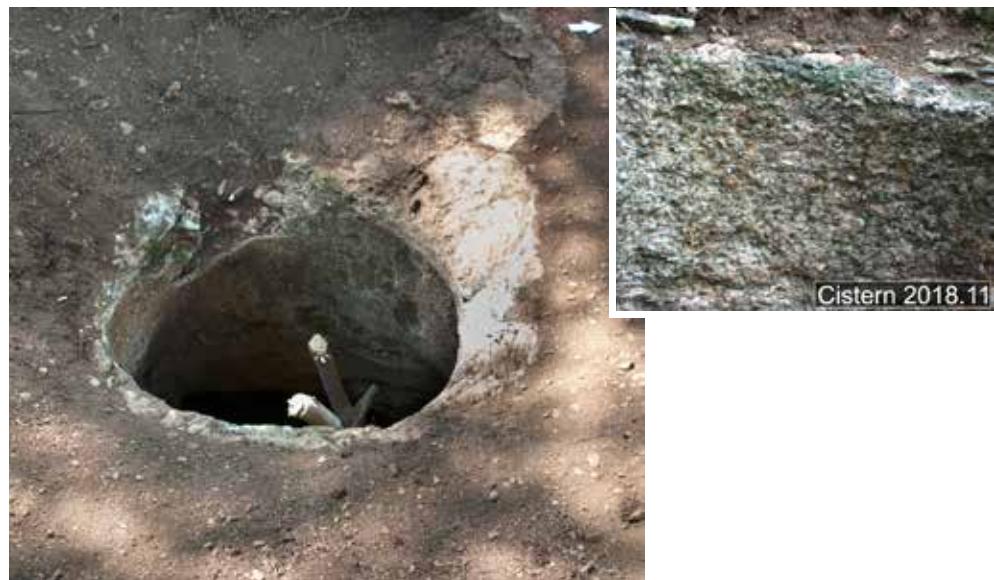
Fig. 14. Cistern 2018.11, mouth, with a diameter of 85–90 cm. With detail of lining. Photographs by Patrik Klingborg.

The next cistern is found on the north side of the Bisti, about 25 m from the coast and approximately 45 m from the point where the coast of the promontory turns south. The opening and a large section of the body can be seen (Figs. 14). Inside the cistern modern refuse competed for space with a young fig tree.

With the exception of a small section in the south-west the whole circumference of the mouth, measuring 90 cm east–west and 85 cm north–south, is preserved at the modern surface level. The neck reaches a maximum depth of 40 cm. Below this the body of the cistern expands into an irregular flask

shape visible to a depth of 225 cm below the modern surface. Part of the body is collapsed on the south side.

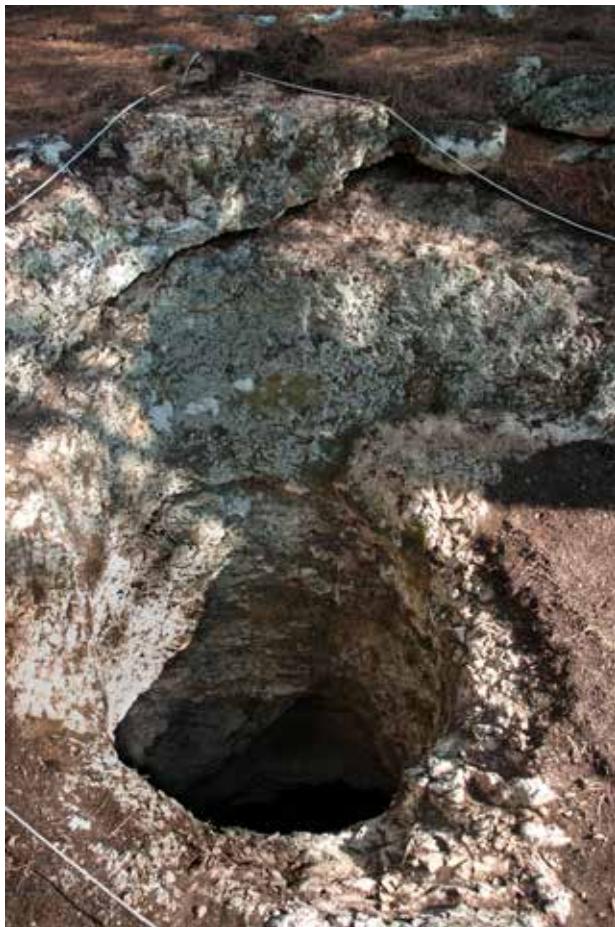
Fig. 15. Cistern 2018.12, upper section and opening. Photograph by Patrik Klingborg.

About 20 m directly south-east of cistern 2018.11 and 45 m south of the north coast a further cistern is found (Fig. 15). It is superficially similar to cistern 2018.10 with an upper section cut in a rock outcrop face and a neck continuing down below the modern surface until it expands into the body. As with the other cisterns a deposit of rocks, organic material, pine needles, and soils is visible at the bottom. Overall, this cistern is in a poor state of preservation.

Notably, the bedrock in which the cistern was cut is very loose and flaky, fragmenting extremely easily. This would reduce the effort needed to construct the cistern, but also make it structurally unsound, as testified by the current state of preservation. The gradually expanding shape can almost certainly be attributed to the dangers of a more traditional approach. The complete lack of visible lining suggests that the cistern was never made waterproof. This may indicate that the construction was never completed, perhaps as it was viewed as unusually dangerous. A less likely possibility is that all the lining has fallen off the fragile walls. In Halieis similar installations have been interpreted as wells by Bradley Ault.⁵⁴

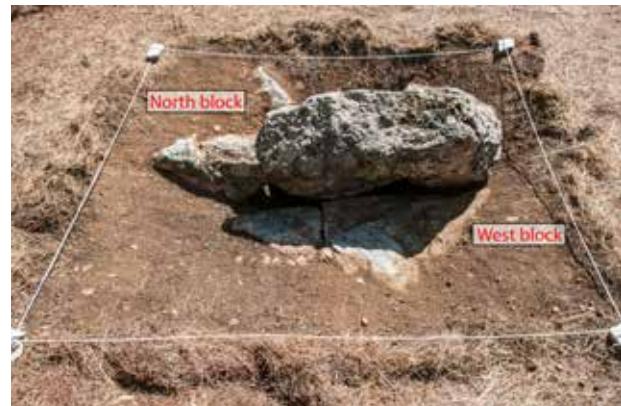
Fig. 16. Cistern 2018.13, surface view. Photograph by Patrik Klingborg.

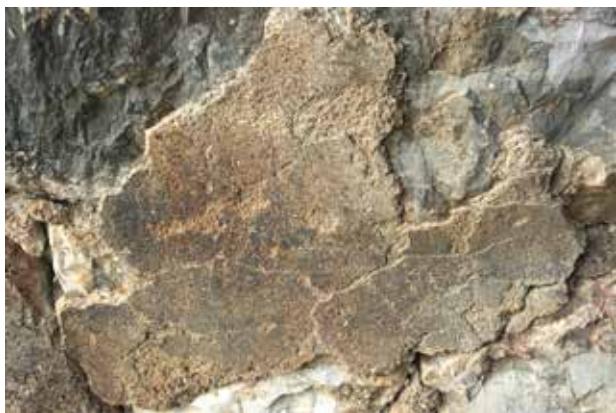
Fig. 17. Lining of cistern 2018.14 with miscolouration. Photograph by Patrik Klingborg

The cistern located 35 m north of the north-east corner of the temple foundations is unique on the Bisti as it has clearly been reused in modern times; at least the surface structures and upper 150 cm of the neck are modern. Additionally, a basin has been constructed to the south abutting the square *puteal*. This may have functioned as a pre-basin (equivalent of the ancient *prolakkion*) when the cistern was used in recent times. It is not known from where the water was collected, as no buildings with suitable roofs exist in the area. Possibly surface run-off was used, but this would radically reduce the quality of the water.⁵⁶ The cistern seems to no longer be in use as burned wood has been dumped in it.

The mouth of the cistern is covered by a square *puteal* constructed in cement and local, roughly rectangular stones. On each corner a concrete and brick base projects upwards with a metal fastening for a (now missing) drawing mechanism. The construction technique is reminiscent of the 19th-
