Annual of the Swedish Institutes at Athens and Rome

From 2D and 3D documentation to 4D interpretation

Building archaeological conclusions and workflow strategies gained by remote study of *Insula V 1*, Pompeii

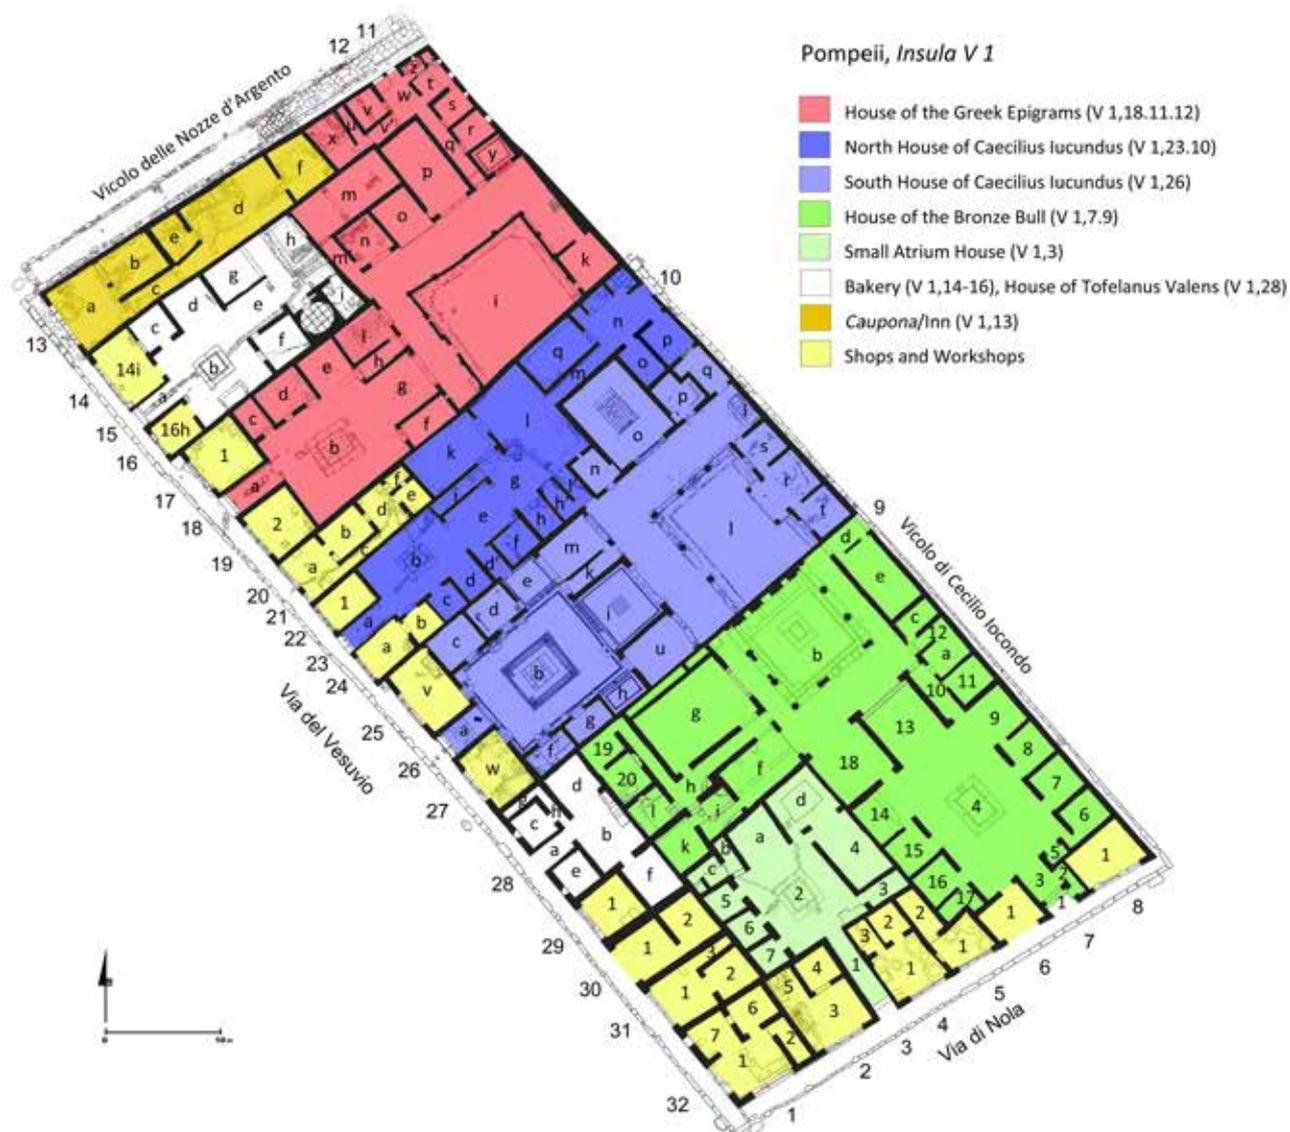
Fig. 1a. Insula V 1. Use of space in AD 79. The houses are known by names (referring to special finds or to the presumed imperial-age owner: Caecilius Iucundus, Tofelanus Valens) and by entrance numbers attributed to them in research. Letter or number sequences from entrance towards rear designate ground-plan rooms (when referred to in text, the number of the main entrance precedes the room designation). All main entrances open onto the two thoroughfares, Via di Nola to the south and Via del Vesuvio to the west. Illustration: Henrik Boman & Ezequiel Pinto Guillaume.

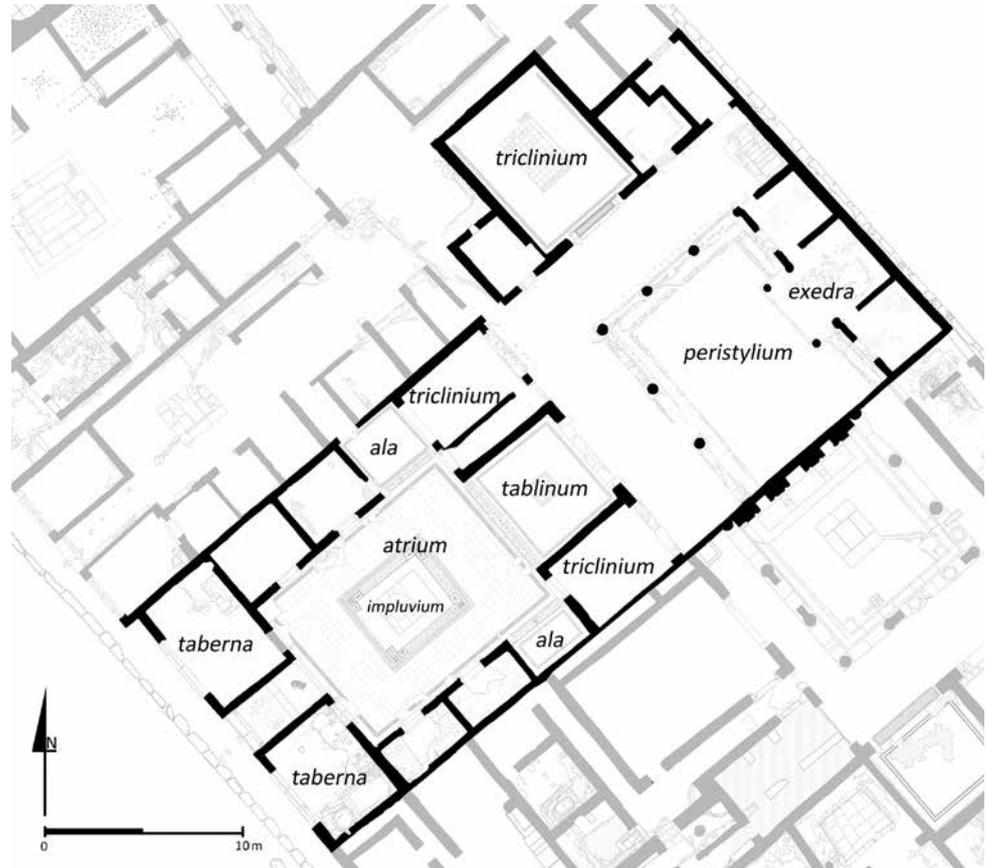
Fig. 1b. The South House of Caecilius Iucundus (V 1,26) in AD 79, demonstrating the typical division of ground-plan space in a traditional atrium house. Small rooms (cubicula) flank two large partly or mostly non-roofed spaces, the atrium and peristyle areas. The latter included a garden and surrounding colonnaded porticoes, onto which dining/banqueting halls (triclinia) opened. In this case, the east side of the originally three-sided portico was rearranged as two rooms with windows and a central exedra extending the roofed space into the garden. The atrium was the traditional working and reception space, often equipped with a subterranean cistern with, on top of it, a collecting pool, impluvium. Two rooms without separation walls towards the atrium was situated at its rear. Between atrium and peristyle, the stately tablinum was reserved for the householder's business and display, and a corridor gave access between atrium and peristyle. The entrance (fauces), situated between two front-shops (tabernae), also had a corridor layout. Illustration: Henrik Boman & Ezequiel Pinto Guillaume.

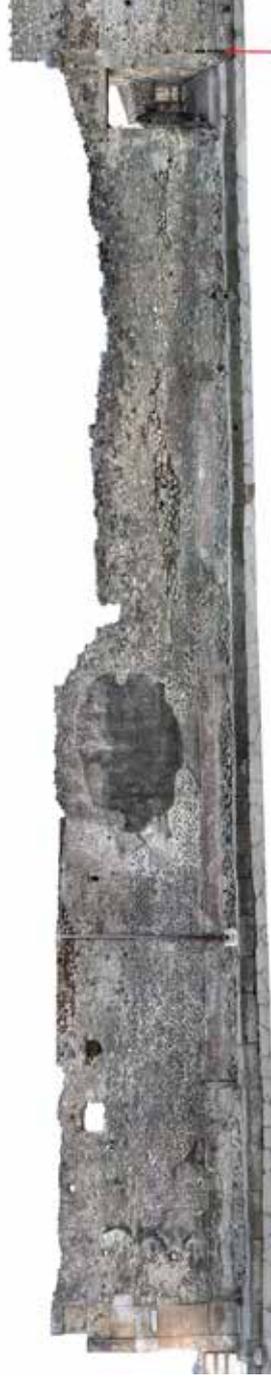
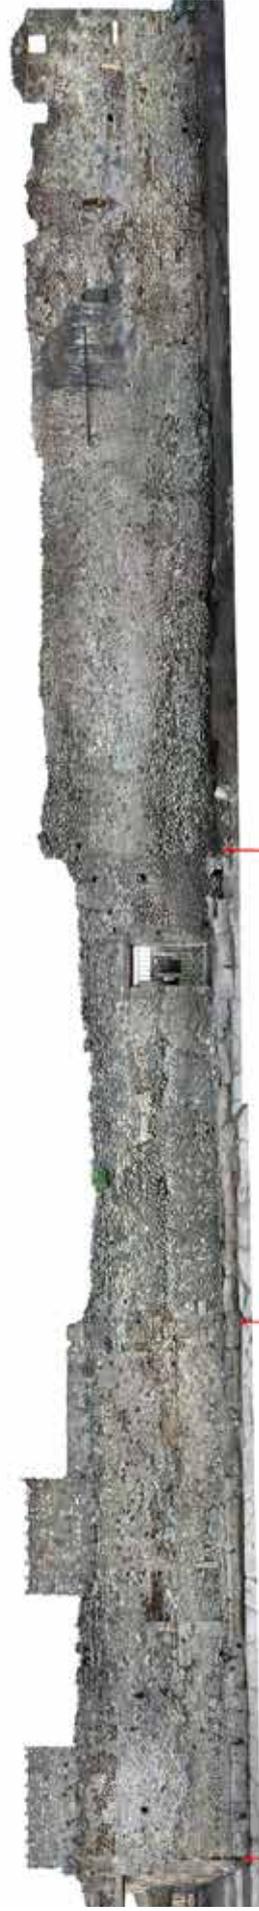
Fig. 2. East perimeter of Insula V 1, façade towards Vicolo di Cecilio Iocundo. Changes in stone material (indicated by arrows) mark the boundaries of four properties. Photograph & oribmosaic: Hans Thorwid. Feature highlights: Henrik Boman. The arrow between V 1,7.9 and V 1,26 is shown twice.

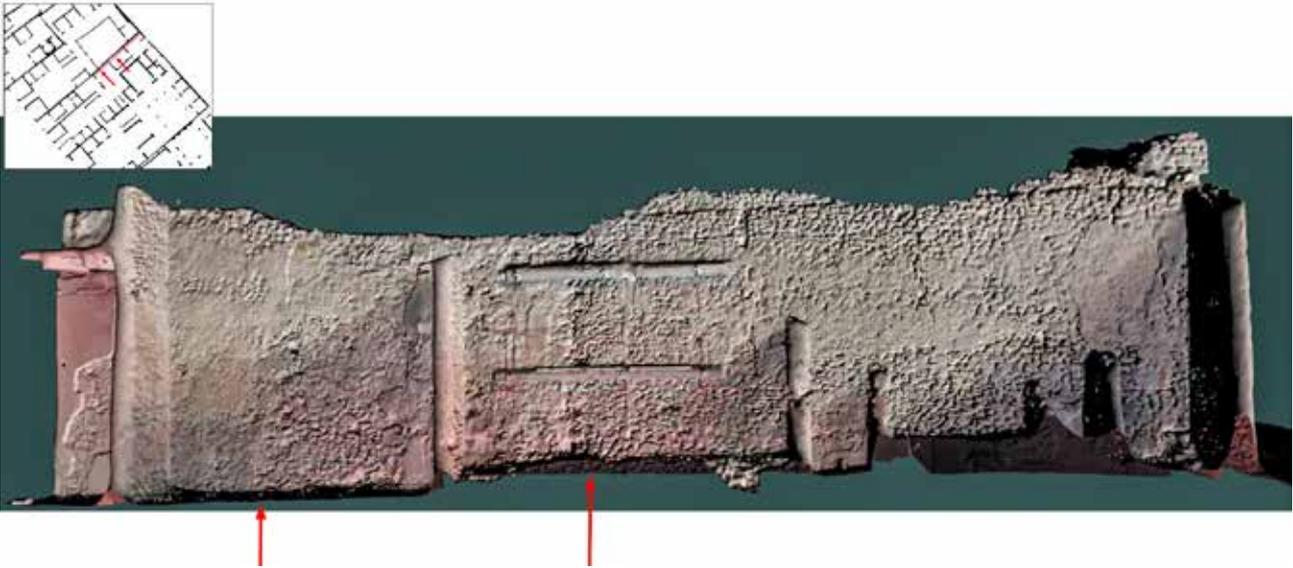
Fig. 3. East part of the boundary between the House of the Greek Epigrams (V 1,18.11.12) and the North House of Caecilius Iucundus (V 1,23.10) displayed as a wall-string. South elevation with inner divisions cropped away. The arrows indicate two abrupt changes in masonry texture. To the right, the wall “wound” indicating a robbed boundary return, to the left a change in masonry. Visualization: 3DHOP software. Feature highlights: Henrik Boman.

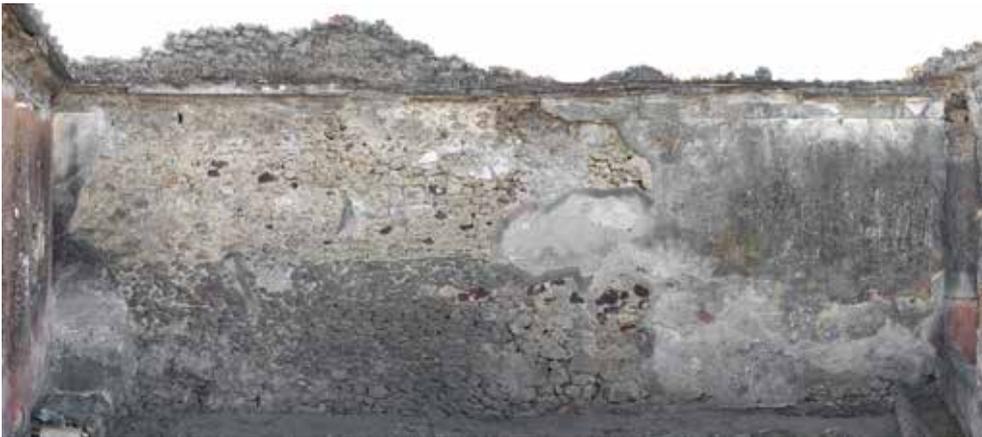
Fig. 4. Rear wall of the peristyle (V 1,18i) of the House of the Greek Epigrams boundary towards the North House of Caecilius Iucundus. Note the abrupt change in masonry corresponding to the wall “wound” on the other side of the wall (Fig. 3). Photograph: Hans Thorwid.

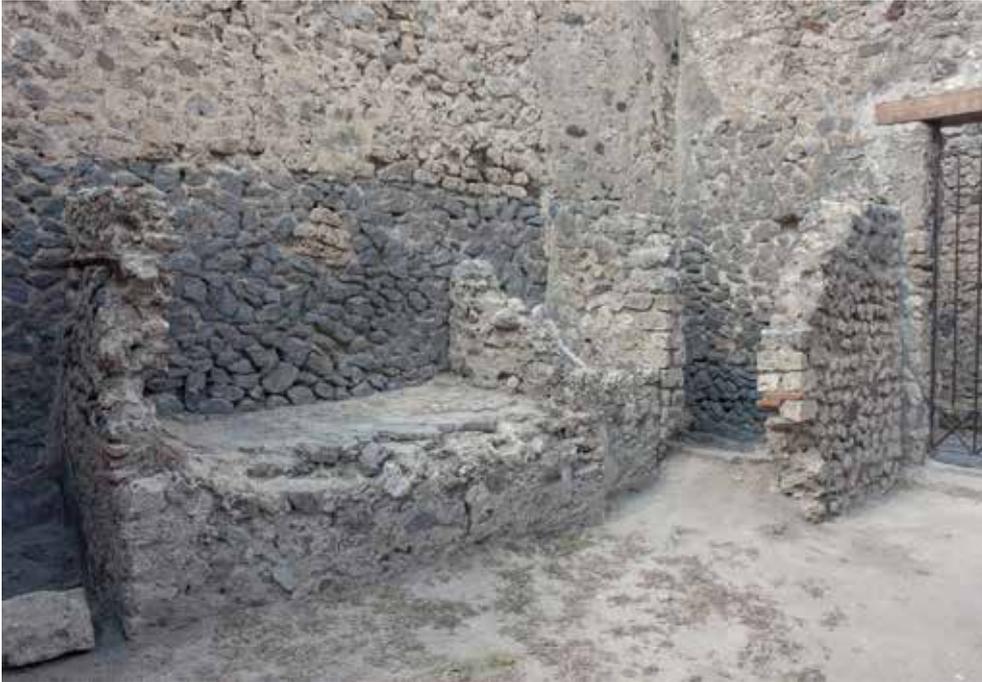
Fig. 7a. View towards the north-east corner of the North House of Caecilius Iucundus (kitchen and latrine, V 1,23n). Homogeneity of texture of the lava incertum characterizes the north boundary and the east perimeter. Photograph: Hans Thorwid.

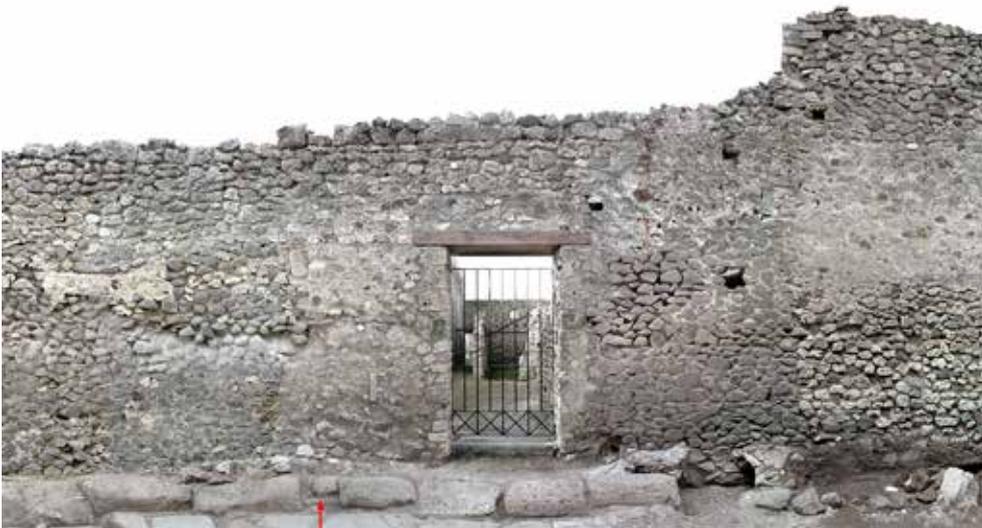
Fig. 7b. Façade towards the east rear street (Vicolo di Cecilio Iocundo). The perimeter wall of the North House of Caecilius Iucundus turns 90° to continue as the north border of the East Property as demonstrated in Fig. 7a. The façade of the House of the Greek Epigrams (to the right) uses stones of lighter colour. The arrow indicates the former extent of a putative shop-opening, later partially blocked (between the arrow and the left side of the doorway). Photograph: Hans Thorwid. Feature highlight: Henrik Boman.

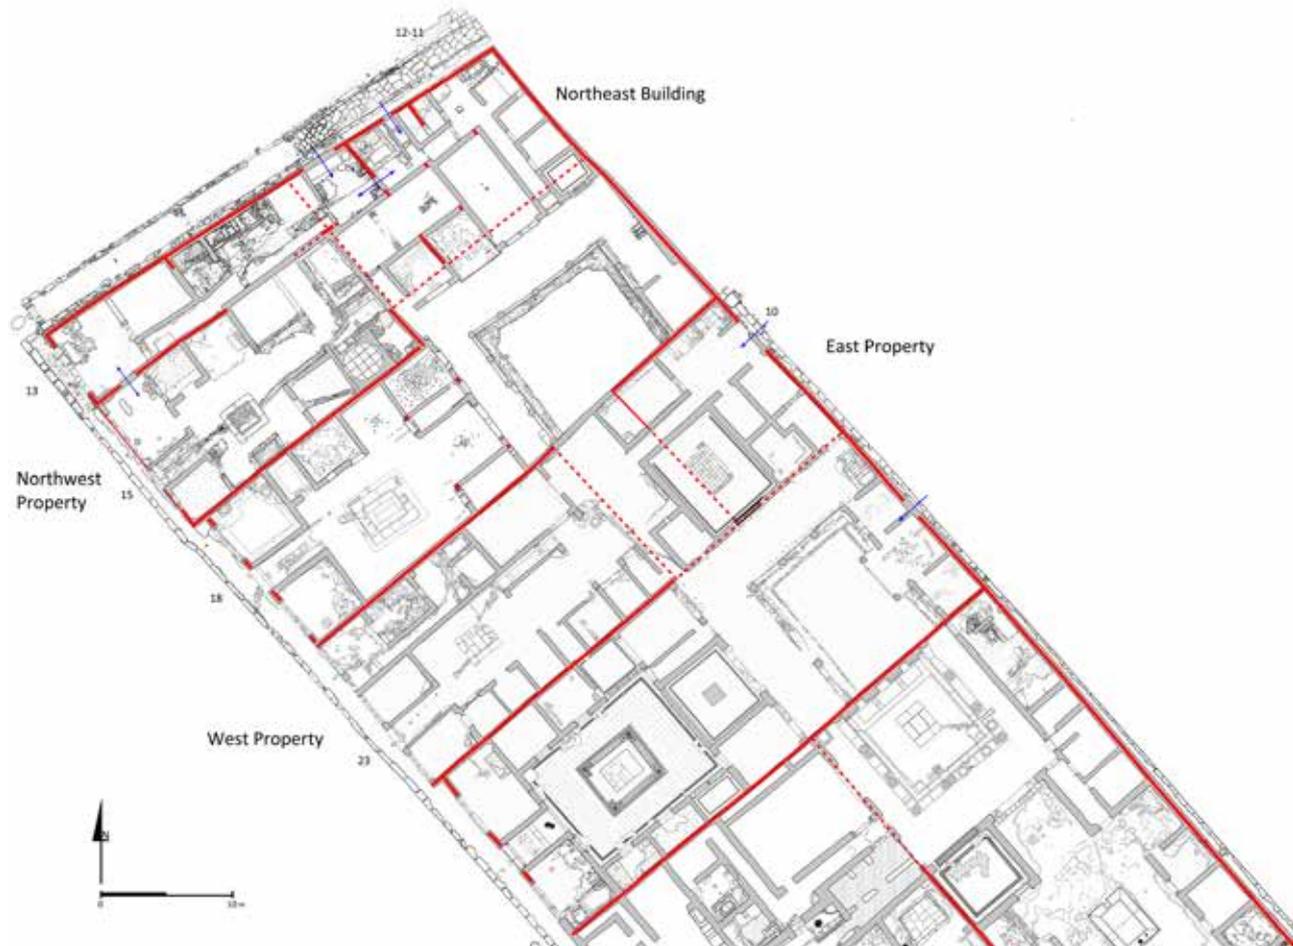
Fig. 8. Early property boundaries in the northern part of the insula reconstructed. Dotted lines indicate hypothetical, or dismantled and later reconstructed walls. Fragmented and truncated walls as well as ashlar-built pillars preserved in inner divisions of the House of the Greek Epigrams are also indicated. Fine lines indicate dismantled boundaries evidenced beneath floor level and blue arrows, doorways. Illustration: Henrik Boman & Ezequiel Pinto Guillaume.

In alignment towards the west, the suggested perimeter return fits remarkably well with a further boundary misalignment noted in the area (*Fig. 9*, Case 3), a sudden change of orientation described by the boundary between the House of the Greek Epigrams and House V 1,15. Together, the two misalignments (Cases 2 and 3) could represent the position of a robbed south boundary of the area, rich in early remains, designated the Northeast Building in *Fig. 8*.

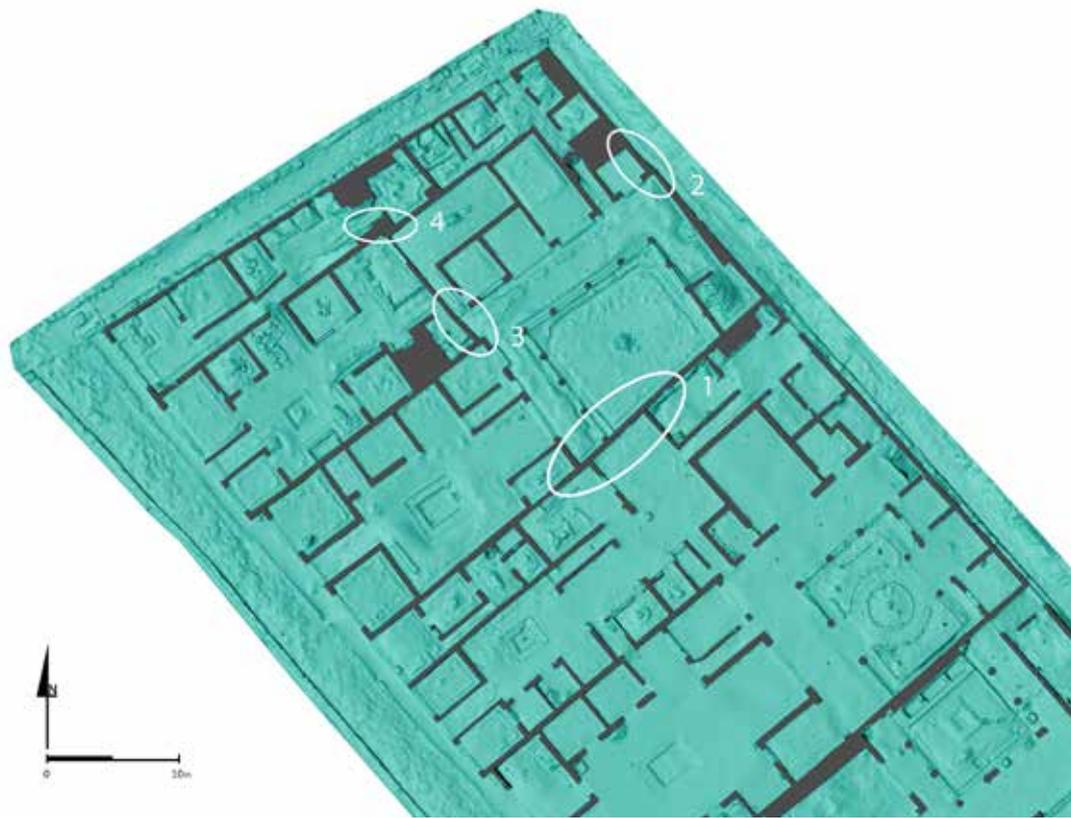
Fig. 9. North part of the insula highlighting areas of perimeter/boundary misalignments (Cases 1–4). Ground-plan produced by means of horizontal sectioning using 3D Studio Max software. To obtain a homogeneous presentation of the walls this image combines two sectioning planes set at different levels (cf. note 21). Processing: Danilo Marco Campanaro. Feature highlights: Henrik Boman.

²¹ The 3DHOP software allows sectioning for study purpose, whereas 3D Studio Max (autodesk—commercial) also provides high-resolution 2D representations (Figs. 9, 19b, 31). The latter visualization highlights the walls as black lines (representing wall interiors to which the acquisition instrument had no reach). These lines are thus created automatically

by the 3D software. When the visualization shows a wall drawn in outline (not as a black line) this means that the chosen level of the horizontal sectioning plane was set higher than the wall in question (the *insula* stands on different levels). For differing results when presenting a same part of the *insula*, compare Fig. 9 combining two different sectioning planes and Fig. 19b using only one. Processing by Danilo Marco Campanaro.

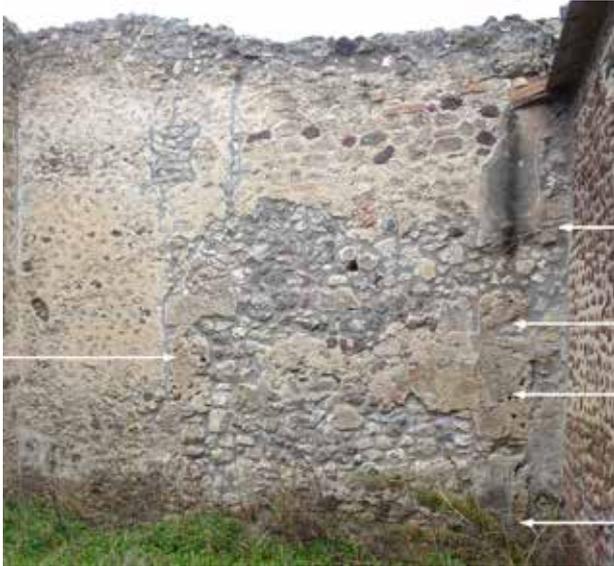
Fig. 10. Wall adjustment closing the boundary towards the House of the Greek Epigrams, viewed from courtyard V 1,23l in the North House of Caecilius Iucundus (south side of boundary). Note the frequent use of Sarno limestone ashlar and fragments within the adjustment. The arrows highlight some of the larger pieces. The full extent of this adjustment covers the space indicated between the arrows in Fig. 3. Photograph: Göran Kindström. Feature highlights: Henrik Boman.

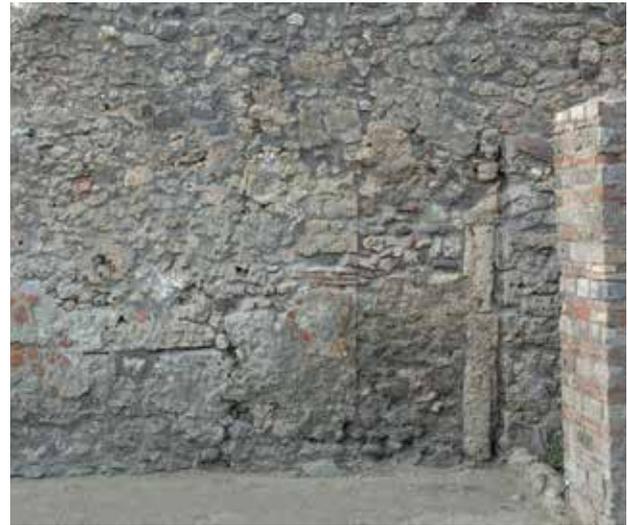
Fig. 11. North atrium wall of the North House of Caecilius Iucundus (V 1,23b). Note the Sarno limestone ashlar: to the right used as a door-jamb of a later walled-up doorway; to the left bridging a foundation fragility (latrine pit dug on the opposite side of the wall). Fragments are present as well. Photograph: Hans Thorwid.

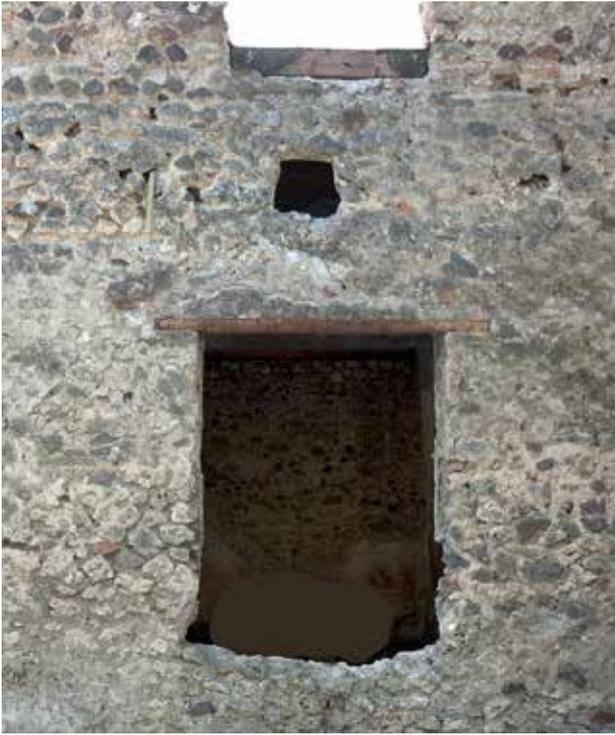
Fig. 12a. Window of triclinium V 1,23k, opening towards and viewed from courtyard V 1,23l. Photograph: Hans Thorwid.

The creation of two *triclinia* (V 1,23k and V 1,26o²²), each with a large window opening towards the formerly non-enclosed space (to remain an open courtyard, V 1,23l, up to the end of Pompeian city-life) marks the new private use of a space possibly held in common in earlier days (Figs. 12a, b). *Triclinium* V 1,23k still preserves traces both of a mortar floor (*opus signinum*) with tessellated inlays judged by specialists as typical of the latter half of the 1st century BC, and older wall decorations beneath the extant (late 3rd-style) ones.²³

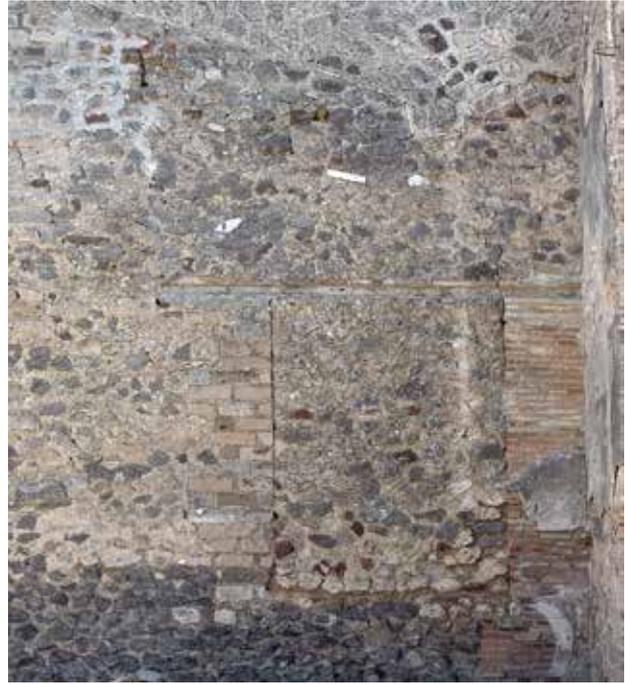
Fig. 12b. Walled-up window of east triclinium (later V 1,26o) opening towards and viewed from courtyard V 1,23l (see also Fig. 13). Photograph: Hans Thorwid.

ion Sanctuary (I 6,4).⁶⁹ Furthermore, in both, light intake was provided by a large window, opening over a garden area. In the case of V 1,23, the window of the east *triclinium* (later V 1,260) provided a view along the main axis of the house, through the wide *tablinum* (V 1,23e) to the entrance (Figs. 12b, 13).

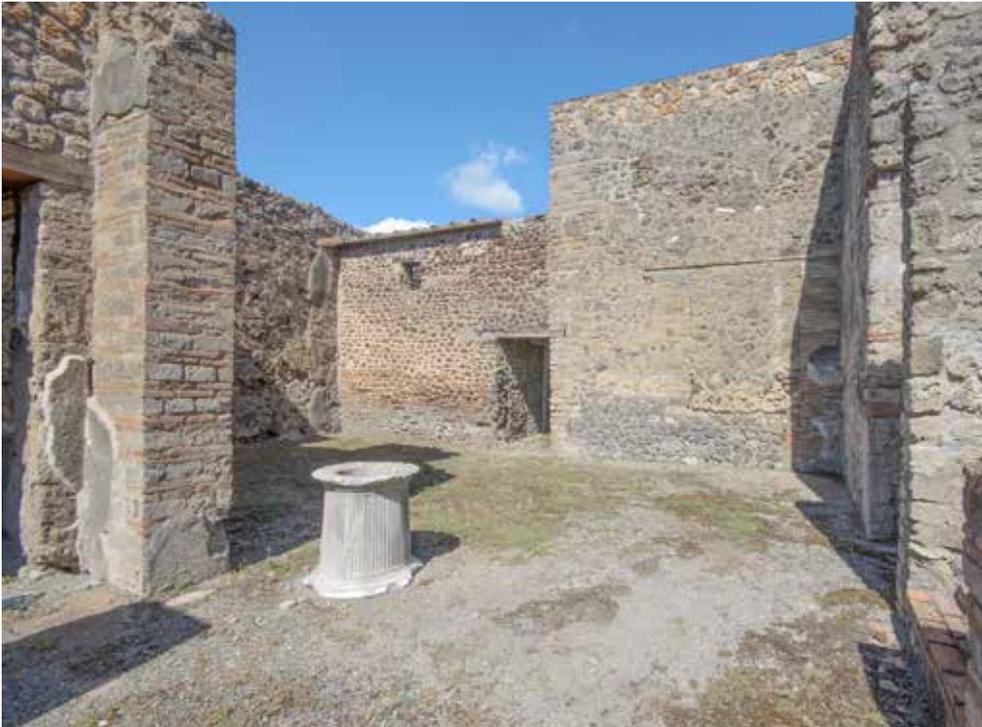
Fig. 13. Courtyard (V 1,23 l) with puteal (well-head) above the cistern. Doorway of triclinium V 1,23k to the left. Façade of the east triclinium (V 1,26o) with walled-up window at the rear (see also Fig. 12b). Photograph: Hans Thorwid.

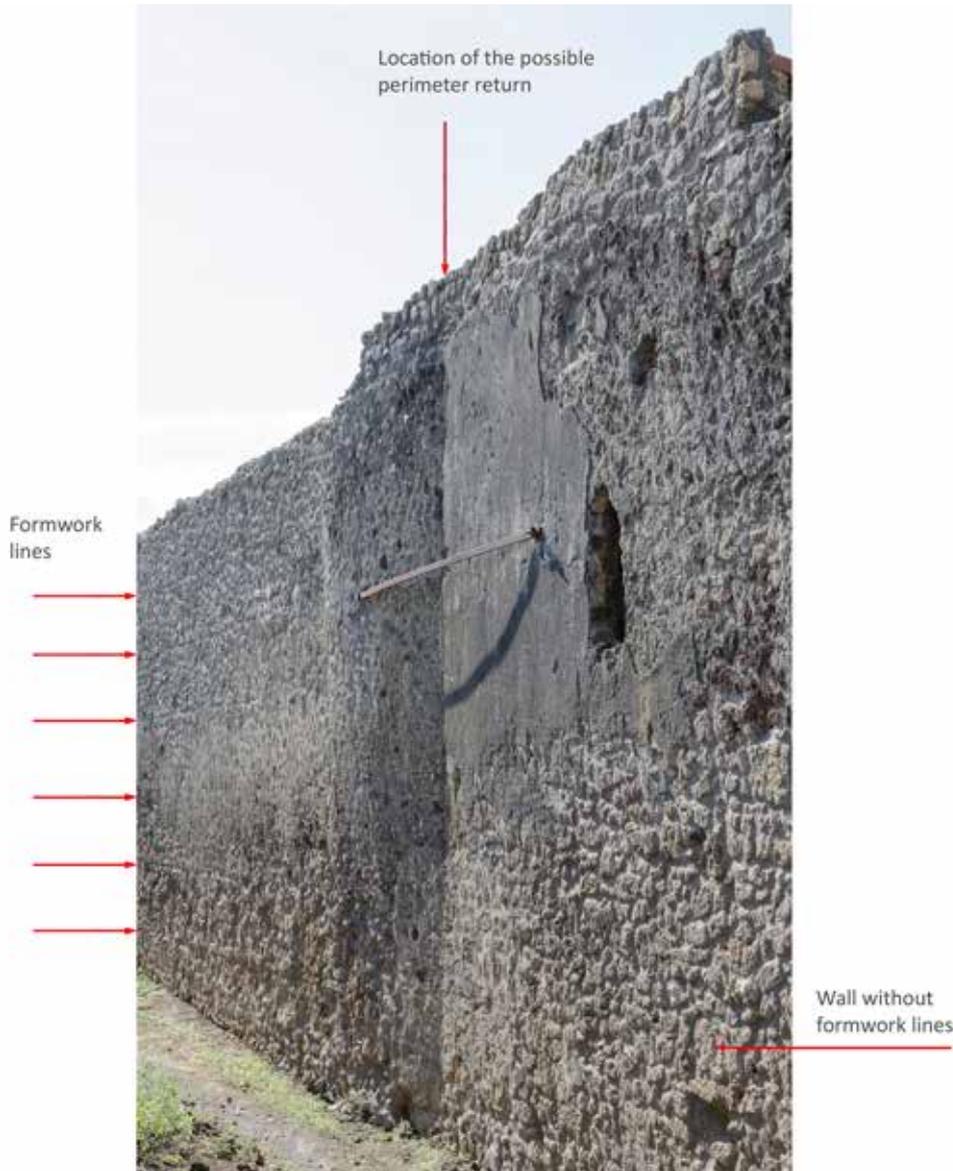
Fig. 14. Looking south on the east façade (perimeter) of the House of the Greek Epigrams, along Vicolo di Cecilio Iocundo, showing the oblique wall section adjusting the mismatch between the long straight line of the late Samnite insula perimeter and the north part of the perimeter of the House of the Greek Epigrams. Arrows indicate formwork lines in the masonry south of the adjustment. Photograph: Hans Thorwid. Feature highlights: Henrik Boman.

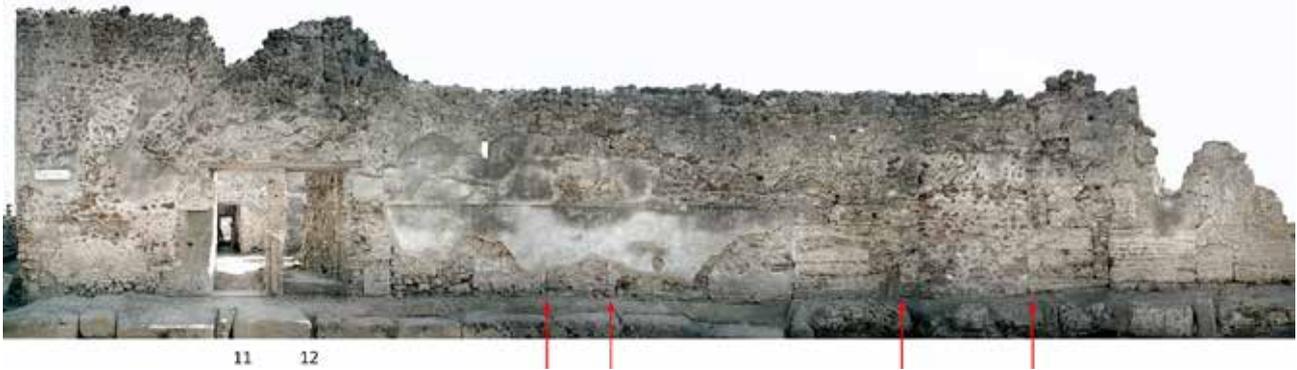
Fig. 15. North façade of the House of the Greek Epigrams (V 1,18.11.12). The arrows indicate two walled-up entrances attributed to the Northeast Building (the larger primarily diminished in width, then walled-up). See also Fig. 8. Photograph & orthomosaic: Hans Thorwid. Feature highlights: Henrik Boman.

Four entrances observed in the north *insula* perimeter, all related to the space ascribed the Northeast Building, mirror the intensive and changing use of the north street front, along Vicolo delle Nozze d'Argento, over time. Two doorways were walled-up in antiquity (*Fig. 15*).²⁸ A third, functioning

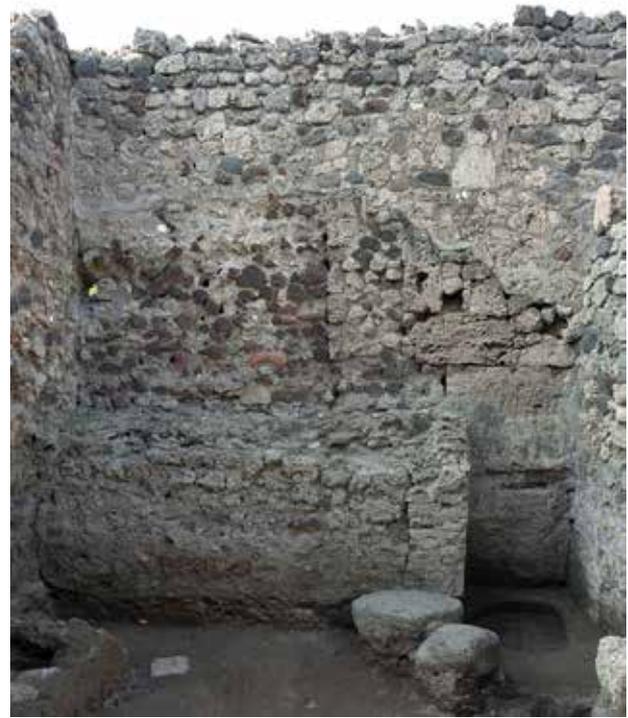
Fig. 16. Kitchen bench in front of a walled-up former entrance in the north façade of the insula (room V 1,13f). Note the well mouth to the right of the bench—this water supply may explain the interest in the room, apparently divested from one property and annexed by another. Photograph: Hans Thorwid.

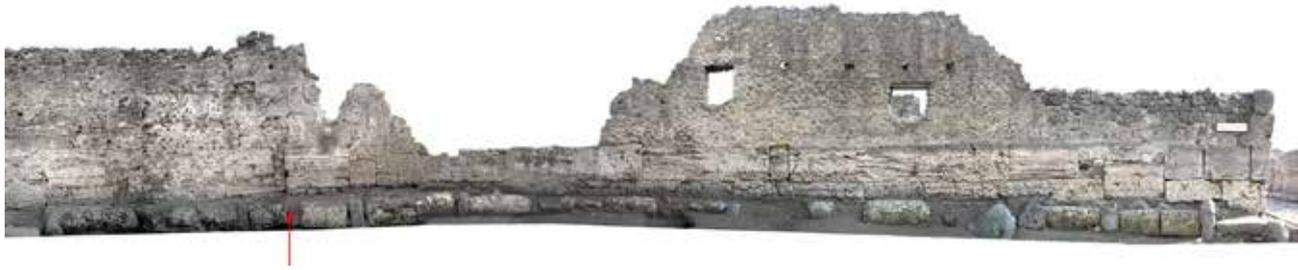
Fig. 17. North façade of V 1,13 along Vicolo delle Nozze d'Argento (a caupona in AD 79). The well-fitted, heavy ashlars of the lower part of the wall represent the oldest building technique (*opus quadratum*) evidenced in this insula. The arrow indicates the position of the pillar suggested as the return of the original north border of the Northwest Property. Photograph & orthomosaic: Hans Thorwid. Feature highlight: Henrik Boman.

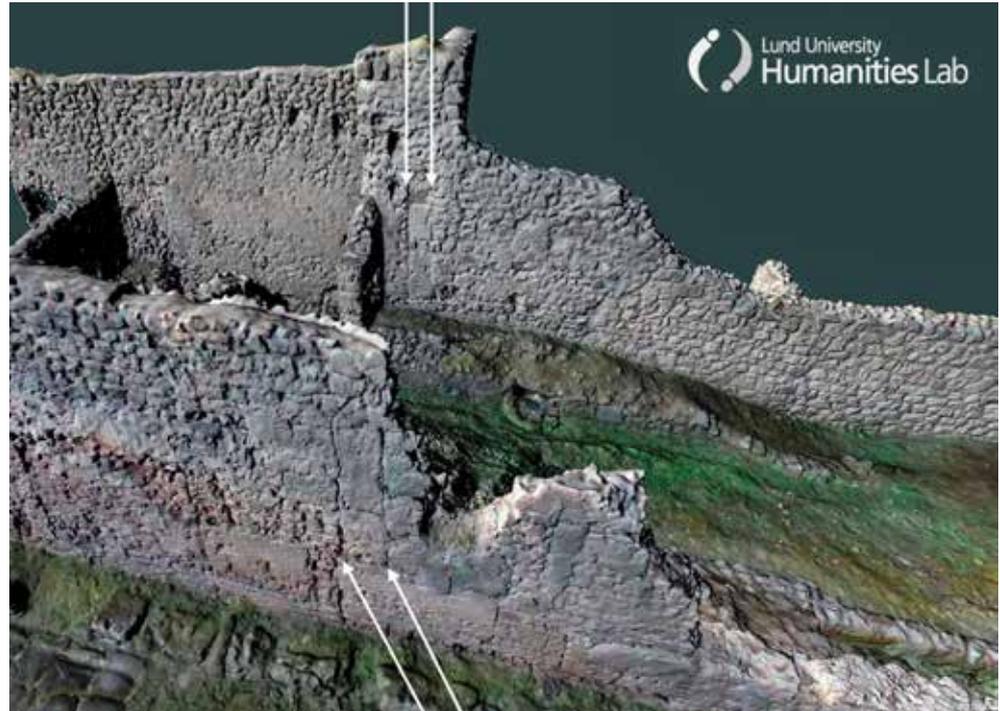
Fig. 18. Pair of stanchions, one on each side of room V 1,13d. Together they may be understood as the remains of the robbed north-east part of the boundary between the Northwest Property (to the right) and the Northeast Building (cf. Fig. 8). Visualization: 3DHOP software. Feature highlights: Henrik Boman.

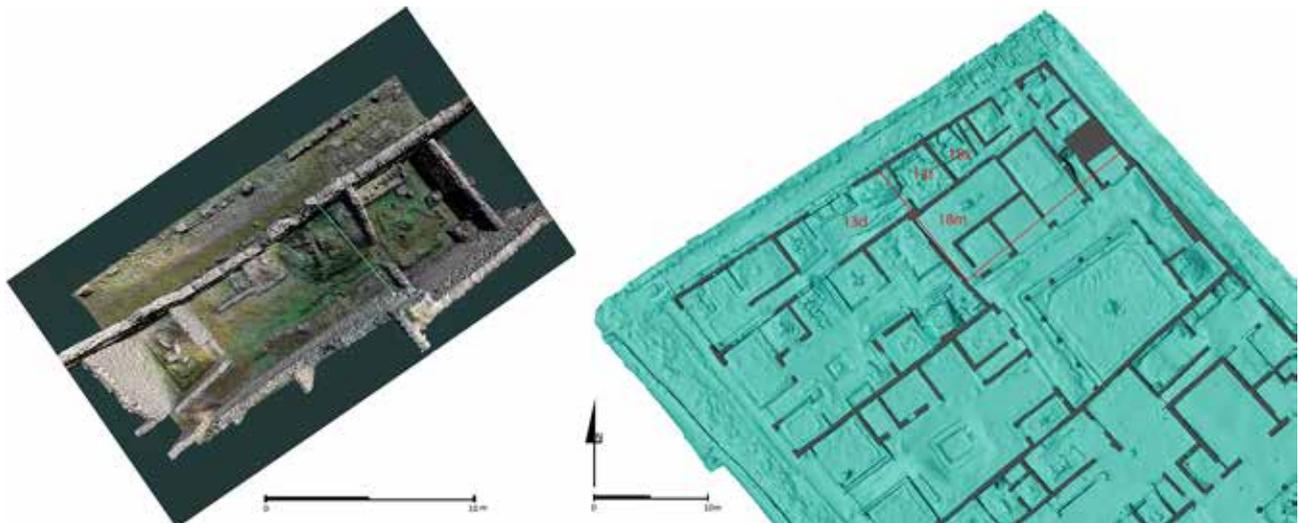
Fig. 19a–b. a: suggested course of the robbed east framework boundary of V 1,13. The green line was generated automatically, by means of the 3DHOP measuring tool. Visualization: 3DHOP software. Processing: Anne-Marie Leander Touati. b: suggested course of the robbed east framework boundary of V 1,13 and its possible continuation as shared boundary between the Northwest Property and the Northeast Building. To obtain a neat indication of the walls, the sectioning plane (cf. note 21) is set above the debris heap in the north-east corner of room V 1,13d. Visualization: 3D Studio Max software. Processing: Danilo Marco Campanaro. Feature highlights: Henrik Boman.

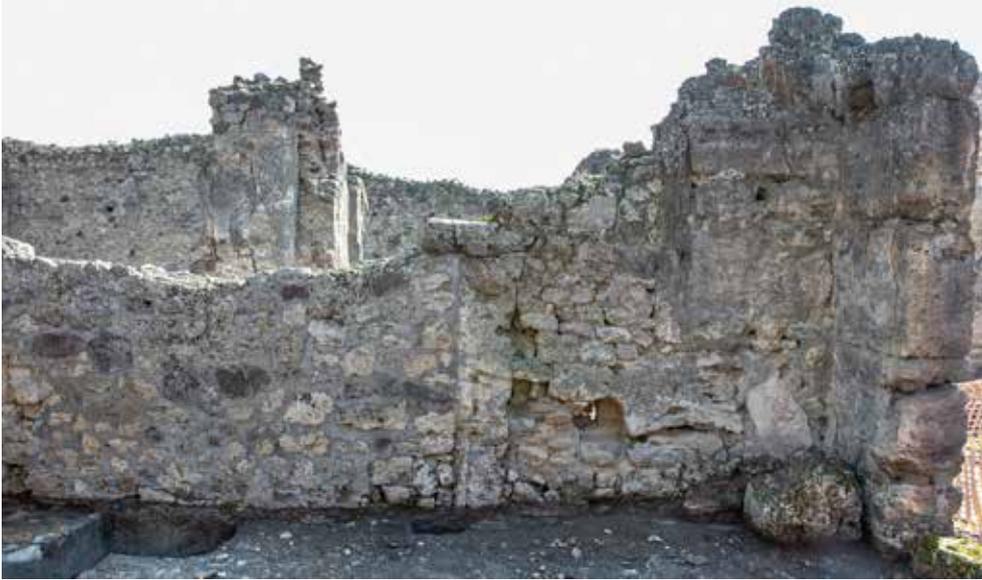
Fig. 21a. Walled-up doorway in boundary separating V 1,13a from V 1.14i, viewed from the north side of the boundary (the *caupona* side). The limestone pillar is understood as the west door-jamb. The east jamb is covered by modern restoration work (covering most of boundary left of the jamb in the image), but visible on the other side of the wall (Fig. 21b). Photograph: Hans Thorwid.

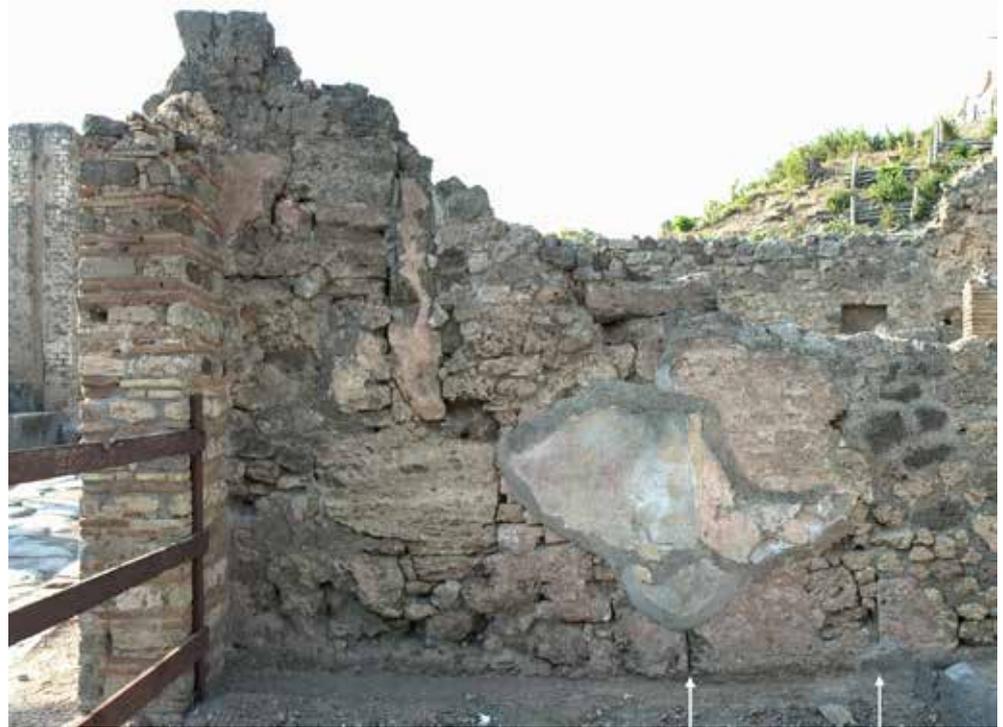
Fig. 21b. Walled-up doorway in boundary separating V 1,13a from V 1,14i, viewed from the south, bakery side of the boundary. Photograph: Hans Thorwid 2007. Feature highlights: Henrik Boman.

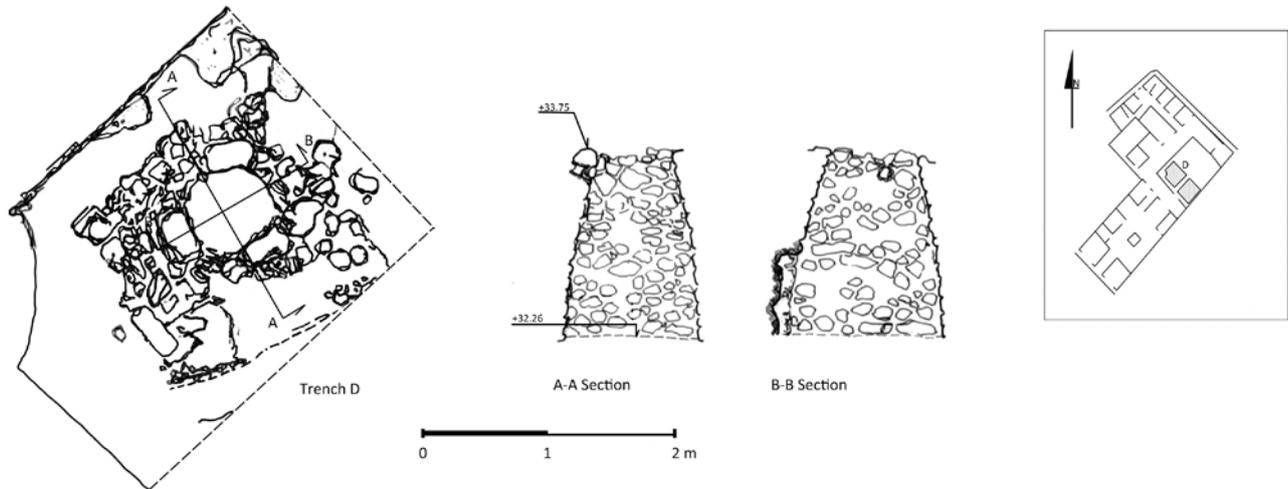
Fig. 22. Well mouth found during excavation in the peristyle garden (V 1,18i) of the House of the Greek Epigrams. The well found was in trench D, located in the south-east part of the garden as shown on the overall plan. Field drawing: Ezequiel Pinto Guillaume, processed by Henrik Boman.

To return to the situation of the early land use in the area later to become House of the Greek Epigrams, a deep well, defined as such and not as a cistern shaft by the lack of conduits to a cistern in this area, was found during excavation in the garden (V 1, 18i, Fig. 22). Although the age of this well has not been established, it allows a hypothesis to be made about the function of the unbuilt area. Its nature, already described above as, at least at times, waterlogged,⁴⁹ may explain

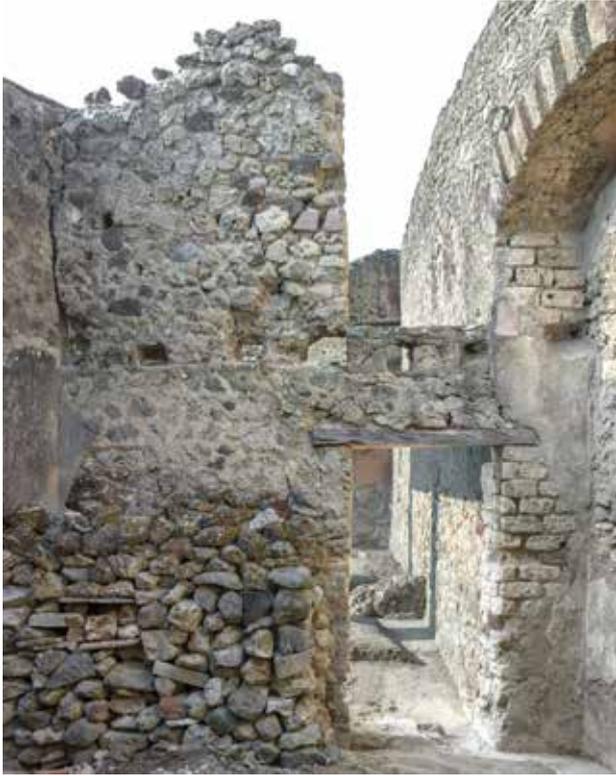
Fig. 23. East insula perimeter with added inner wedge-shaped wall-shell revetment in small tufa blocks. House of the Greek Epigrams, north wall of room V 1,18k. See also the ground-plan produced by means of horizontal sectioning, Fig. 9. Photograph: Hans Thorwid.

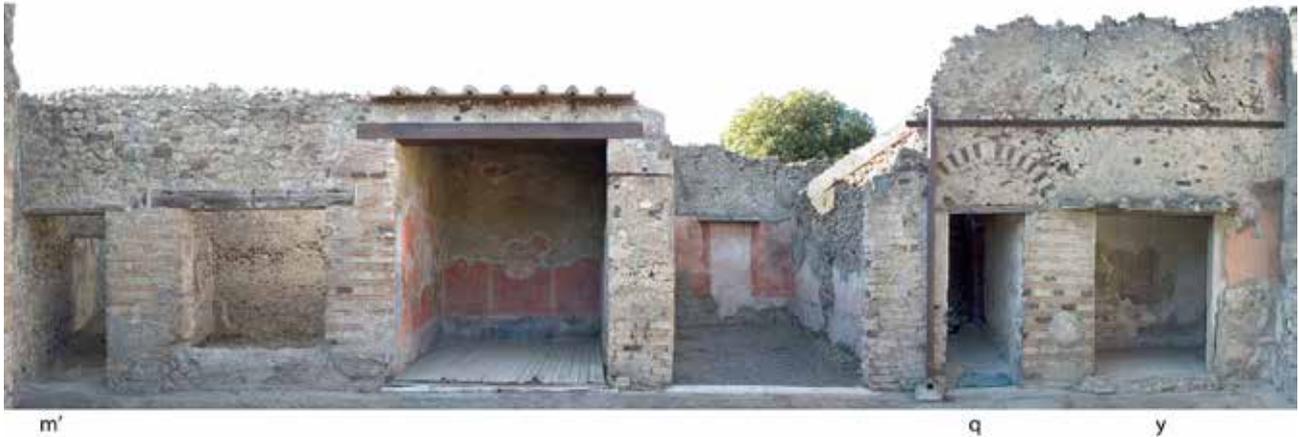
Fig. 24. North garden front rooms of the House of the Greek Epigrams. Note the upwards-sloping floor of corridor V 1,18,q cf. Fig. 20. Photograph & orthomosaic: Hans Thorwid.

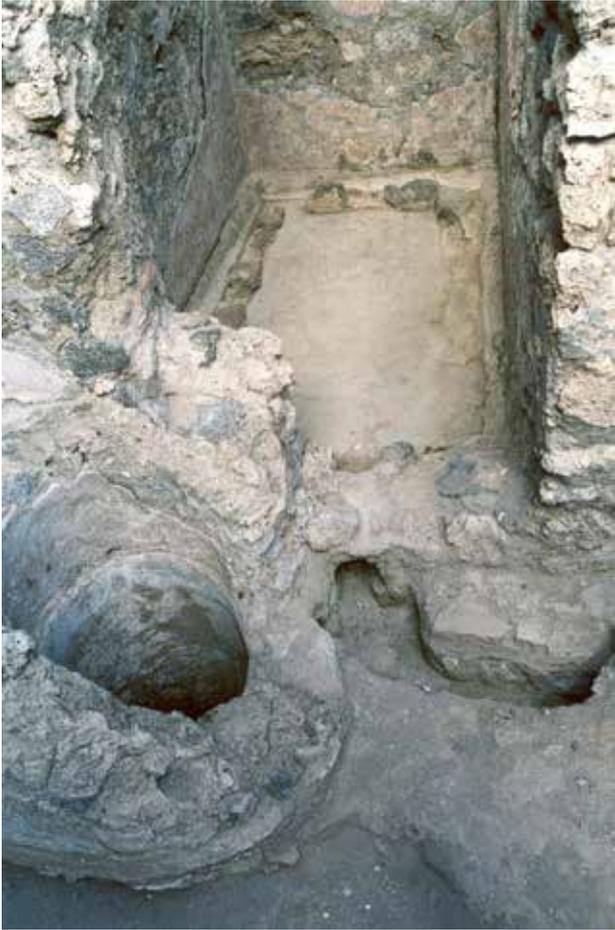
Fig. 25. Cistern mouth in the north-east corner of workshop rear room V 1,20d. Behind, the small and high room V 1,20f, functioned both as a downpipe for rainwater harvesting and as a light-shaft accommodating both room V 1,20d to the west and, by a window in the south wall, room V 1,20e. View towards east. Photograph: Henrik Boman.

to secure its rainwater provision. The high, shaft-like room (Fig. 25) situated in the north-east extreme of the workshop (V 1,20f) had walls and floor covered by hydraulic plaster and functioned as both large downpipe (c. 1.9 x 1.1 m) and light-shaft. Water was led here from the roof above the upper floor above the workshop and from that of the *triclinium* occupying the space east of the workshop area. This, the west *triclinium* (V 1,23k), was entered from forecourt V 1,23g and, as noted above, had a large window towards the open courtyard/garden (V 1,23l). Its west, rear wall abuts the, by now, blocked window, originally built as a light-intake from the neighbour (the earlier open space, but by now become *atrium* [V 1,18b] of the House of the Greek Epigrams). The original wall decorations of the *triclinium* are hidden behind the late 3rd-style decoration still extant. Remnants of a mortar floor with borders of tessellated inlays, lines of cross-patterns consisting of a black *tessera* surrounded by four white ones, agree stylistically with floors firmly identified as belonging to rooms decorated in the late 1st century BC in this *insula*.⁶⁵

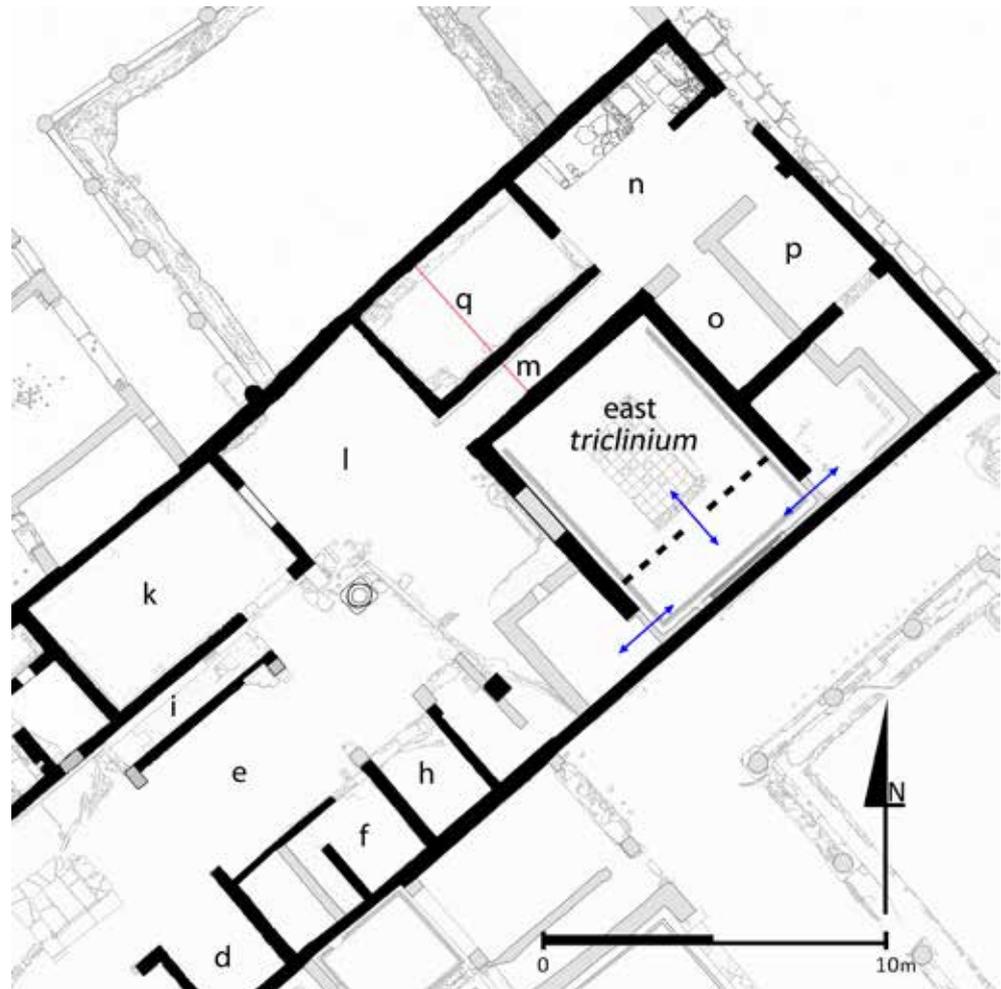
Fig. 26. East triclinium (later V 1,26o) of V 1,23.10 (later North House of Caecilius Lucundus) with surrounding architecture in the 1st-century BC phase. Blue arrows mark accesses to the triclinium by an antechamber with a corridor-like layout. The red line indicates the course of the robbed west boundary of the former East Property. Illustration: Henrik Boman & Ezequiel Pinto Guillaume.
