Annual of the Swedish Institutes at Athens and Rome

From 2D and 3D documentation to 4D interpretation

Building archaeological conclusions and workflow strategies gained by remote study of *Insula V 1*, Pompeii

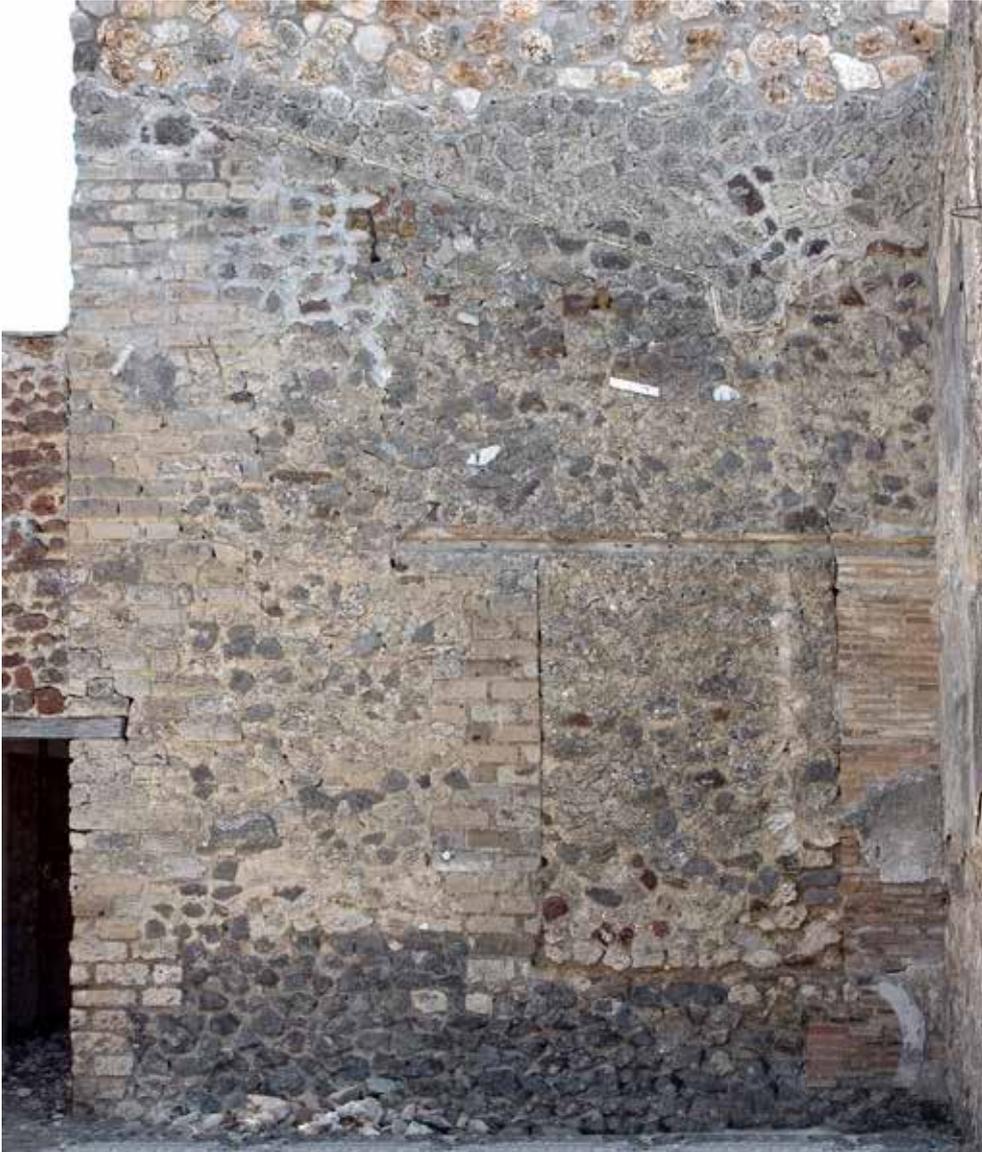
Fig. 27. Opus incertum masonry supported by tuffelli framework. West façade towards courtyard V 1,231 of the east triclinium (later V 1,260). To the right, later brick repair replacing the original southern tuffelli frame of the blocked window. Photograph: Hans Thorwid.

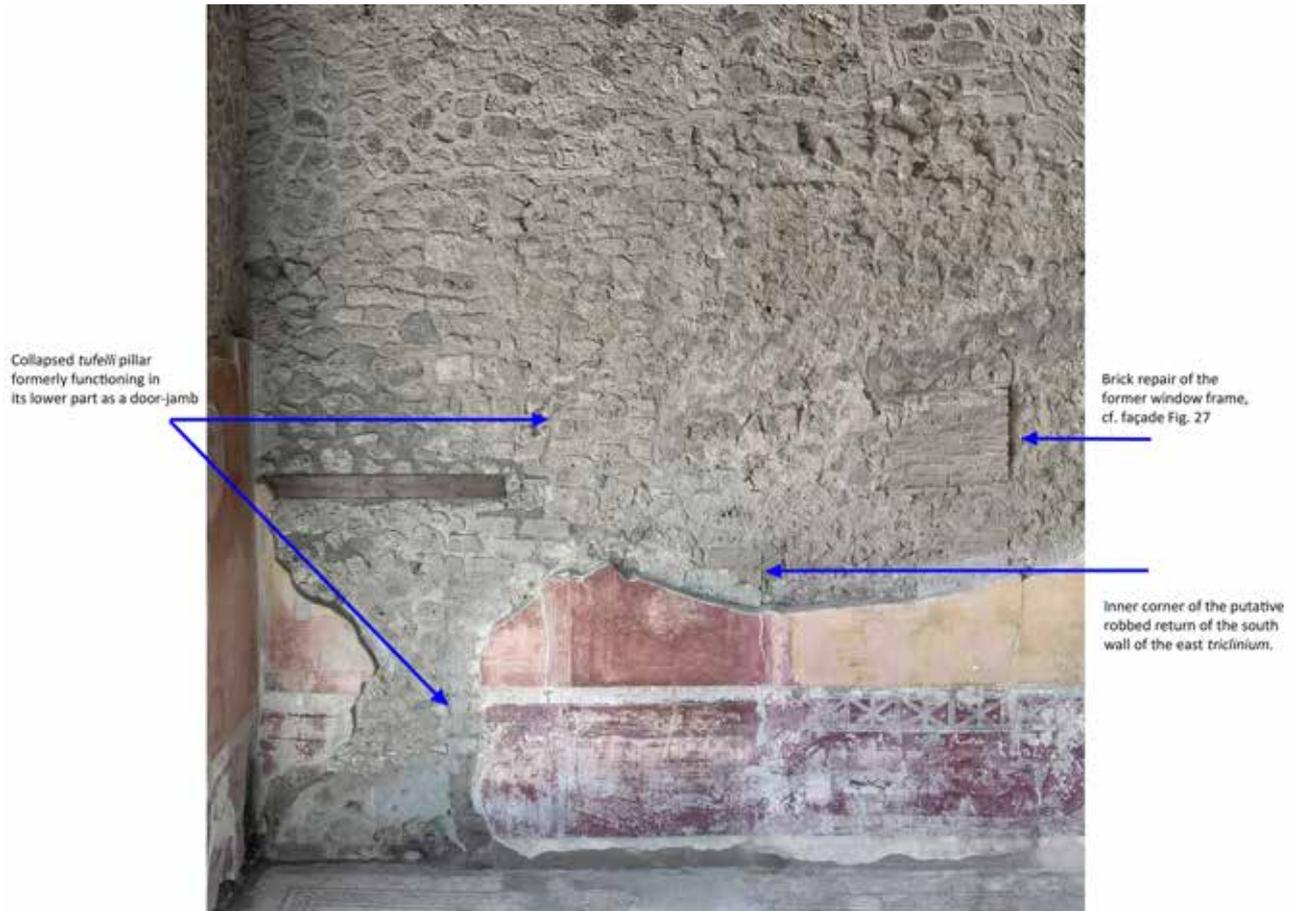
Fig. 28. West interior elevation of triclinium V 1,260. The fallen-off 4th-style decorations reveal construction techniques of and repairs to the wall. Two tuffelli pillars preserve their original position: one framed the entrance of the antechamber, the other standing further north is the putative mark of the return of the wall dividing the earlier east triclinium from its antechamber. Above doorway level, the partly collapsed tuffelli pillar is embedded in an opus incertum fill. This repair belongs to the later phase when the east triclinium was transformed into V 1,260. A brick pillar, substitute for the former window frame (more conspicuous in the exterior elevation, Figs. 12b, 13, 27), assures the strength of this fill. Photograph: Hans Thorwid. Feature highlights: Henrik Boman.

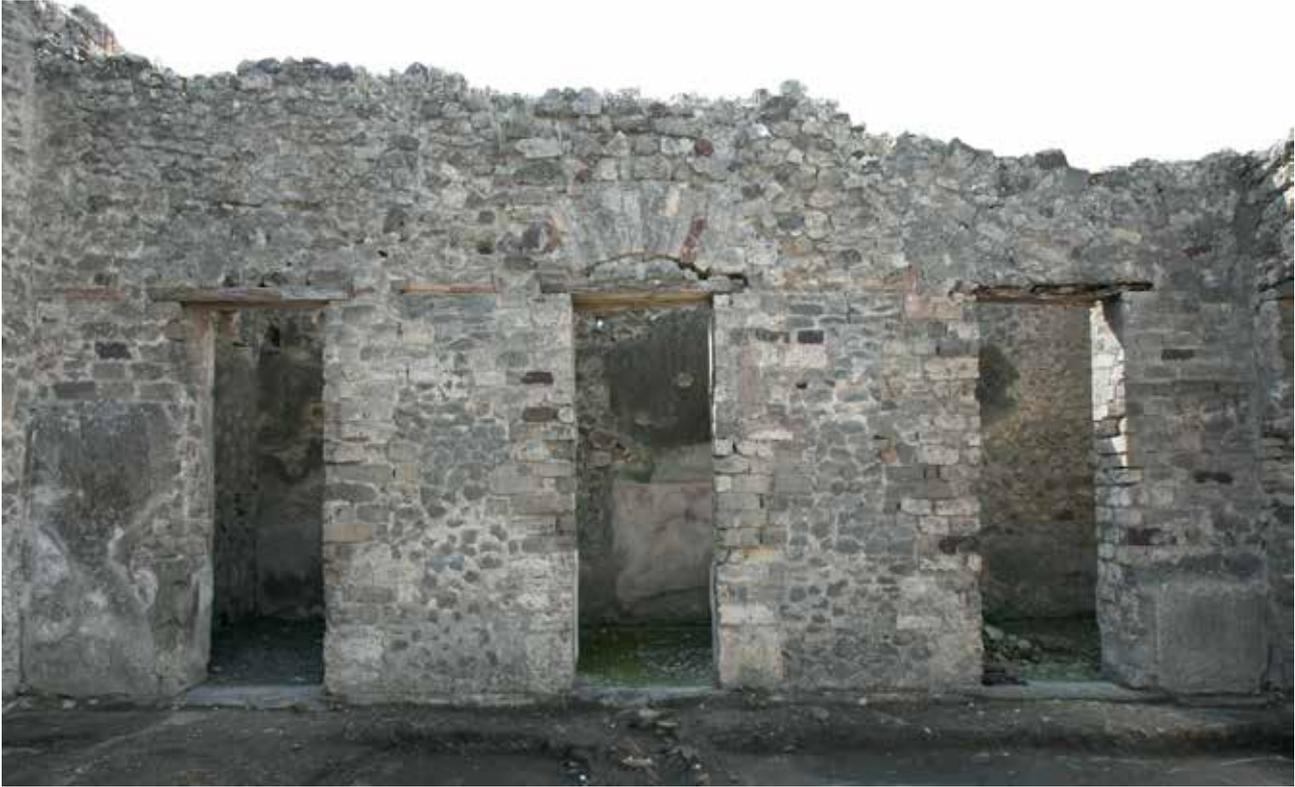
Fig. 29. The imperial-age tuffelli-framed door-ways leading from the atrium towards the cubacula of House V 1,3, west wall of atrium V 1,3,2. Photograph: Hans Thorwid.

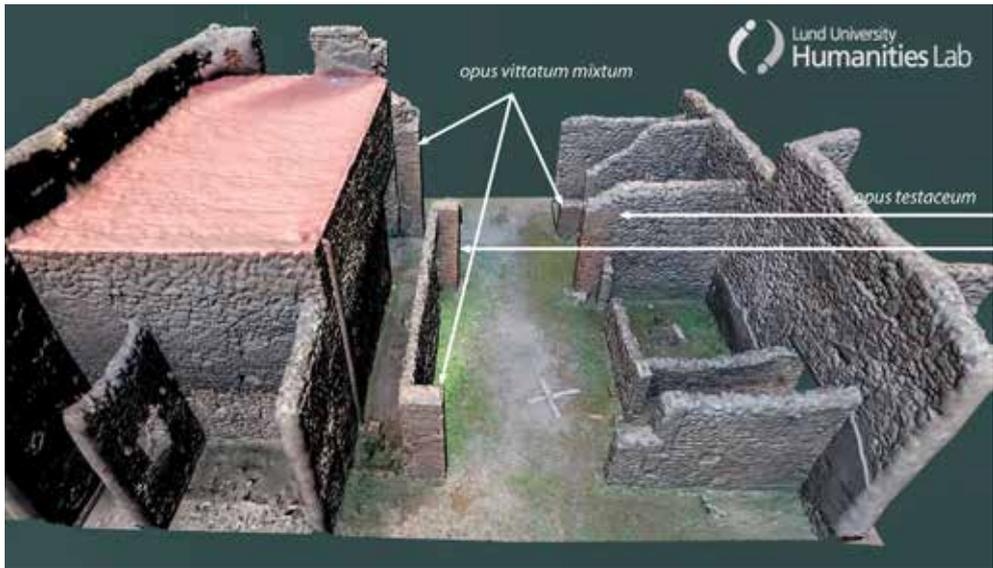
Fig. 30. Bird's-eye view of the middle section of the North House of Caecilius Iucundus centred on its tablinum (V 1,23e). Masonry in brick-and-block (opus vittatum mixtum) or brick (opus testaceum) technique characterizes a series of structural elements, load bearing piers and strengthening pillars in both parts of the new double-atrium house. Visualization: 3DHOP software. Feature highlights: Henrik Boman.

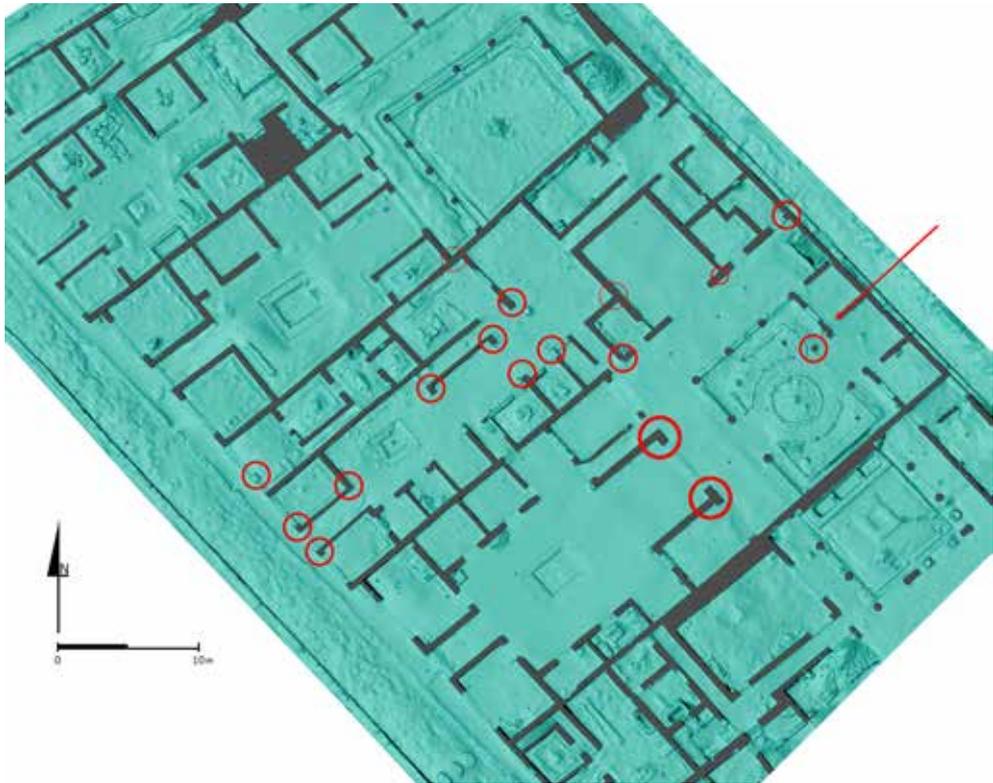
Fig. 31. The distribution and use of brick or brick-and-block masonry reveals its structural part in the architecture of the merge of the two houses to create the double-atrium house of Caecilius Iucundus. The arrow indicates the graffiti-inscribed column giving the name of Emperor Claudius (the intricate patchwork masonry characterizing the columns of the peristyle porticoes is left unaccounted for). Visualization: 3D Studio Max software. Feature highlights: Henrik Boman.

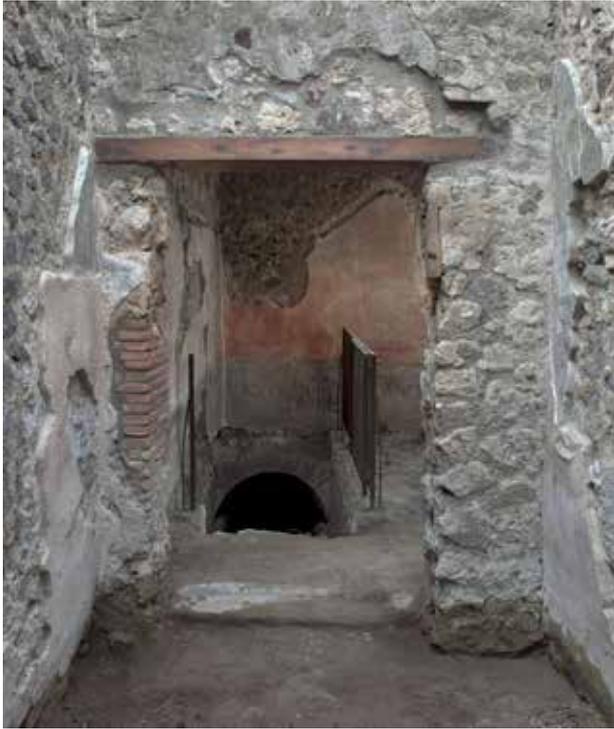
Fig. 32. Brick pillar functioning as a door-jamb in the South House of Caecilius Iucundus. Doorway opened in the east extreme of the former boundary. View towards south and the cellar below the east portico rooms (V 1,26s,r). Photograph: Hans Thorwid.

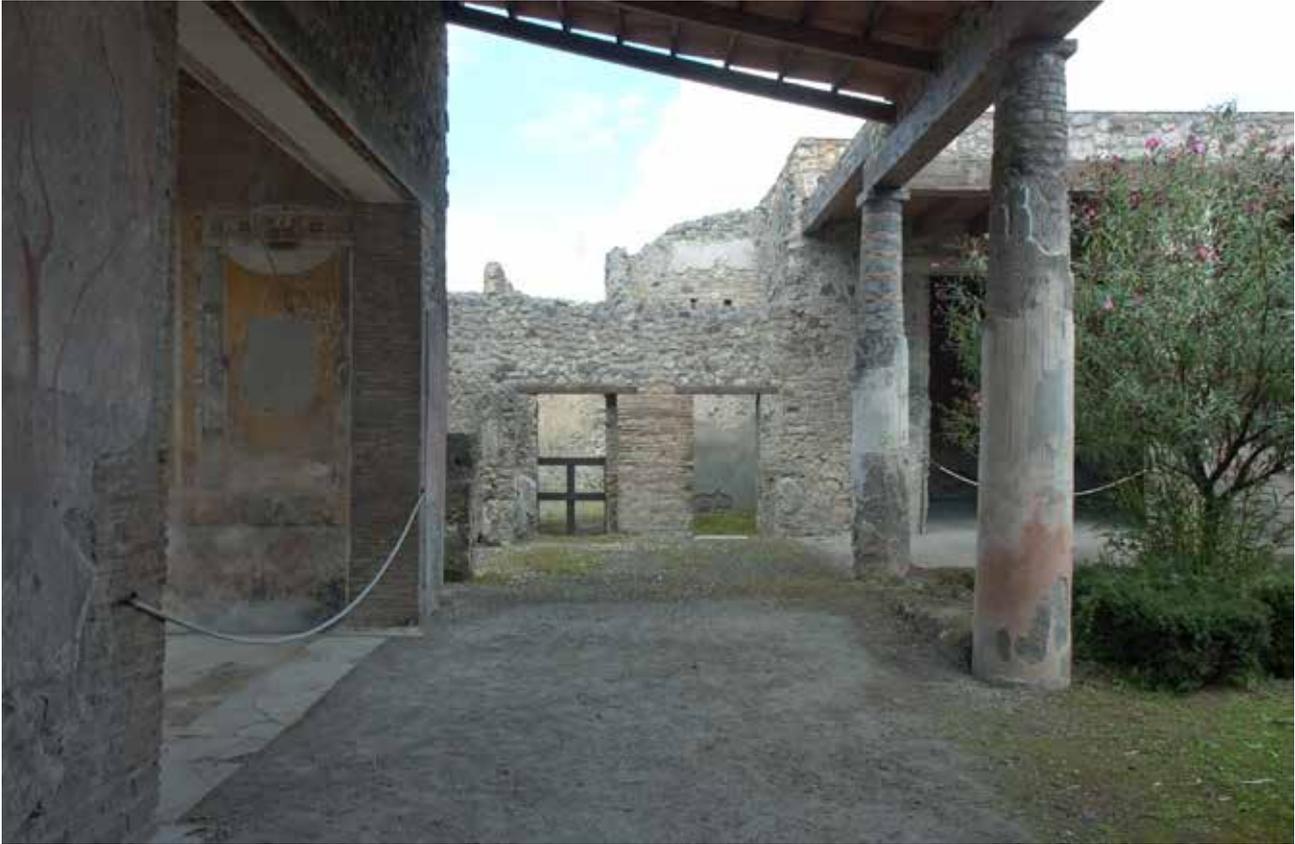
Fig. 33. Wall section in opus vittatum mixtum, support to masonry bridging two openings in the former boundary. View from the west garden portico of the South House of Caecilius Iucundus. The west doorway (left in image) opens on the corridor (V 1,23l) leading to open courtyard (V 1,23n) of the North House; the east doorway is the entrance to the new room (V 1,26n) built to flank the large triclinium V 1,26o (previously the east triclinium of the northern building). Photograph: Hans Thorwid.

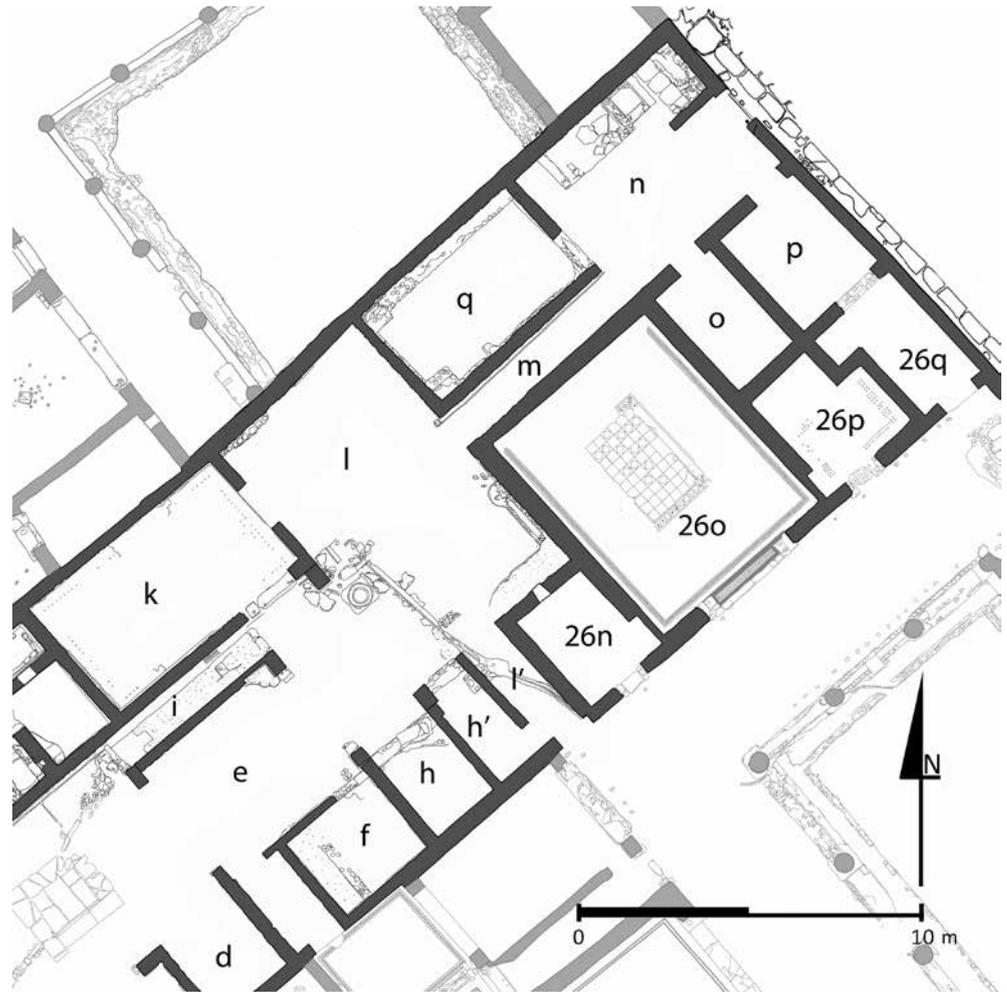
Fig. 35. East part of V 1,23.10 in its Claudian design. All rooms east of corridor V 1,23l are now turned south, towards the lavish peristyle of the new double-atrium house, linking the North and South Houses of Caecilius Iucundus. Illustration: Henrik Boman & Ezequiel Pinto Guillaume.

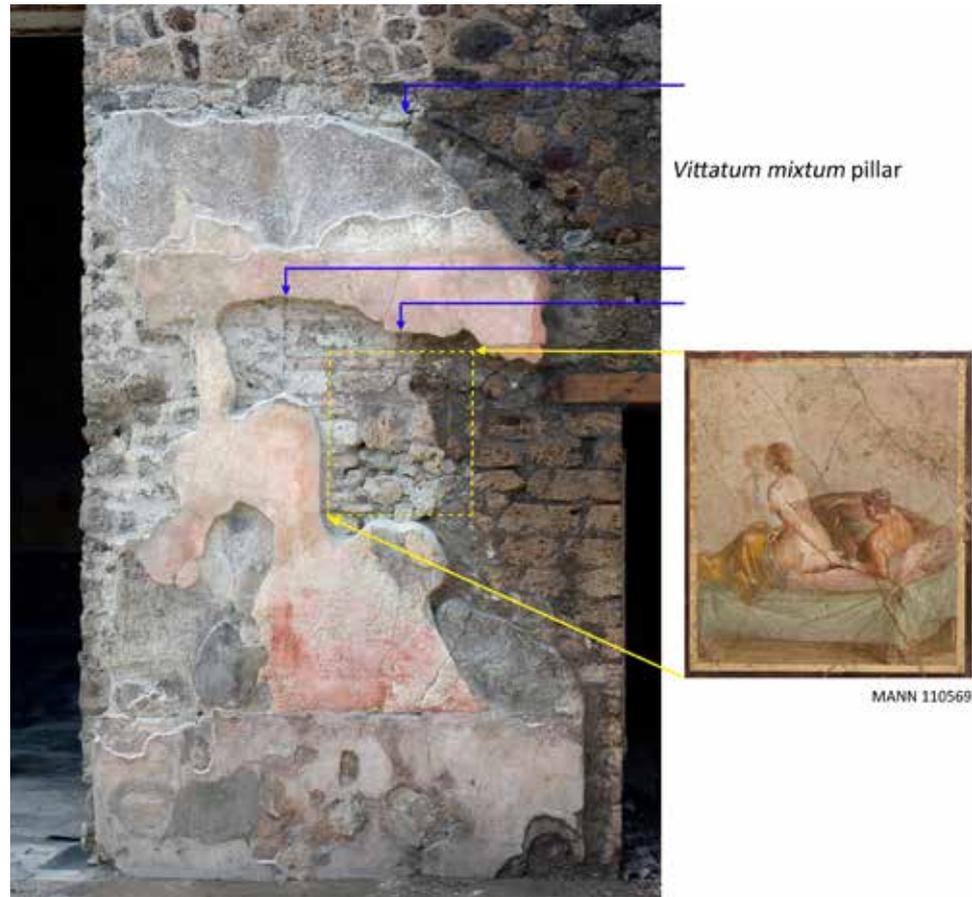
Fig. 36. Opus vittatum mixtum pillar functioning as reinforcement in the wall replacing the old boundary, on the right side of the large doorway of triclinium V 1,26o. The wound in the plaster corresponds to the original emplacement of the well-known erotic painting MANN 110569. Photographs: Hans Thorwid. Feature highlights: Henrik Boman.

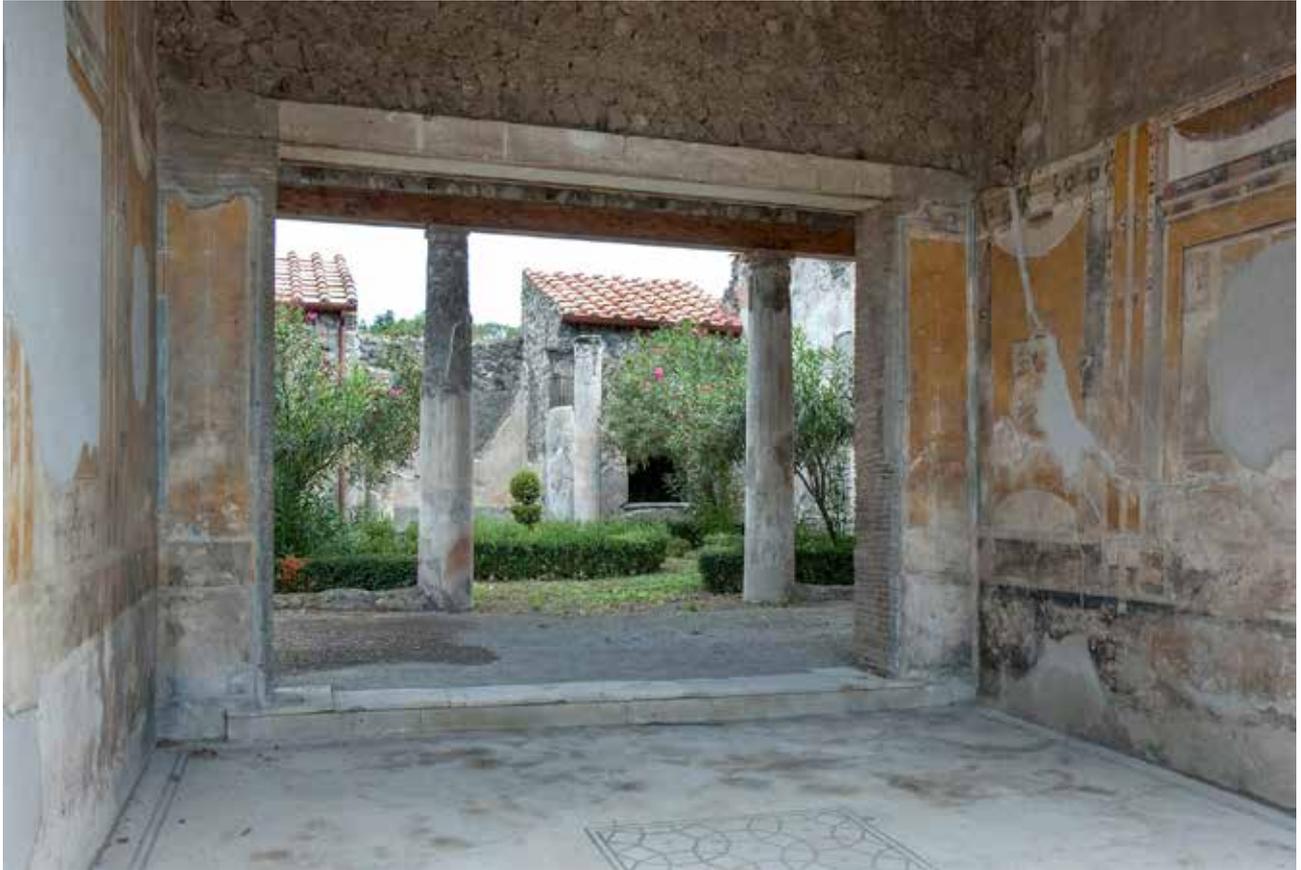
Fig. 37. Tablinum of the House of Caecilius Iucundus (V 1,26i) with wall decorations in the late 3rd style, dated stylistically to the Claudian period. Note the brick piers to which the decorations cling (cf. Fig. 33). Photograph: Hans Thorwid.

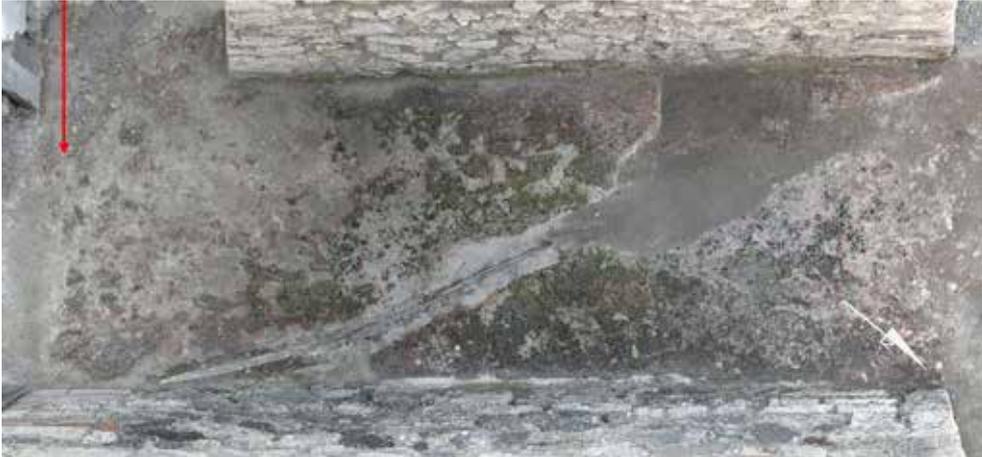
Fig. 39. Corridor (V 1,23l) leading from the open courtyard of the North House (V 1,23l) towards the portico of the South House (V 1,26l). The lead pipe of the aqueduct line passes beneath the brick-and-block-built south-west corner of room V 1,26n. Vertical view looking west. The arrow indicates the position of the former boundary's north face. Feature highlight: Henrik Boman. Photograph & orthomosaic: Hans Iborwid.

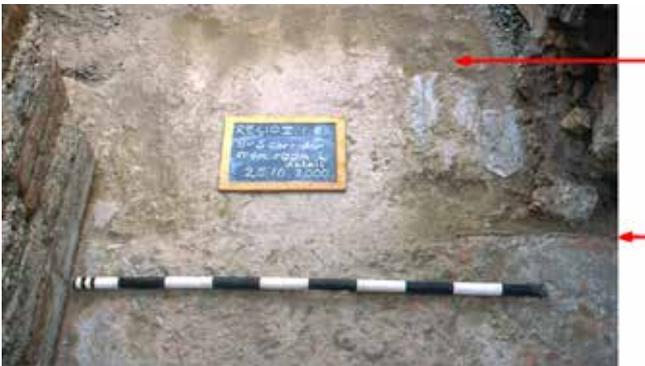
Fig. 38. Doorway between the two parts of the double atrium house of Caecilius Iucundus, viewed towards south, from corridor V 1,23l towards the peristyle area V 1,26l. The arrows mark the position of the dismantled boundary. The lower arrow points at the plaster coating remain of the pre-mege boundary. Feature highlights: Henrik Boman. Photograph: Arja Karivieri.

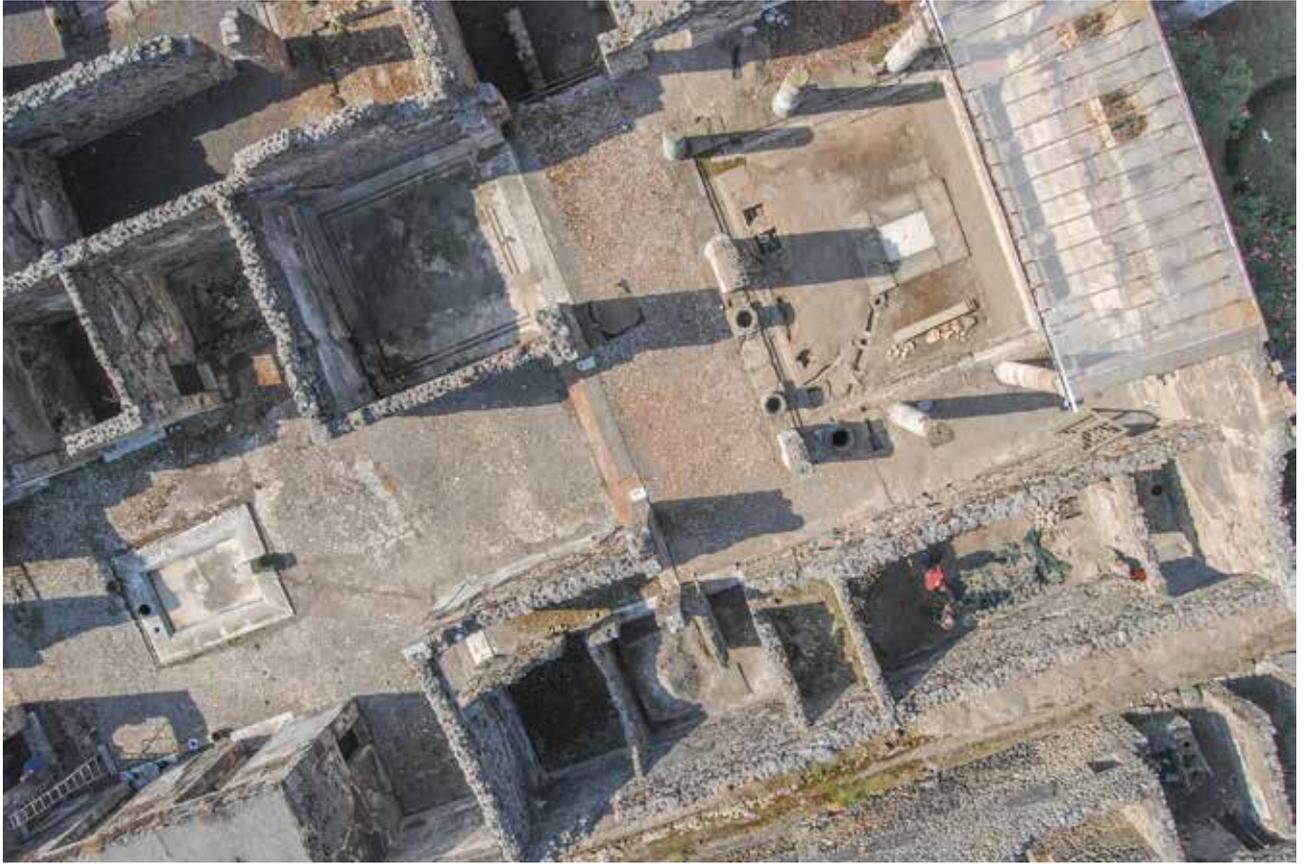
Fig. 40. Atrium and peristyle areas of the House of the Bronze Bull. Aerial view, courtesy of Prof. J.-P. Brun, Centre Jean Bérard.

posing fountain garden (*nymphaeum*, V 1,7b),⁹² the most exclusive of all the prestigious architecture in this city block (Figs. 40, 41).

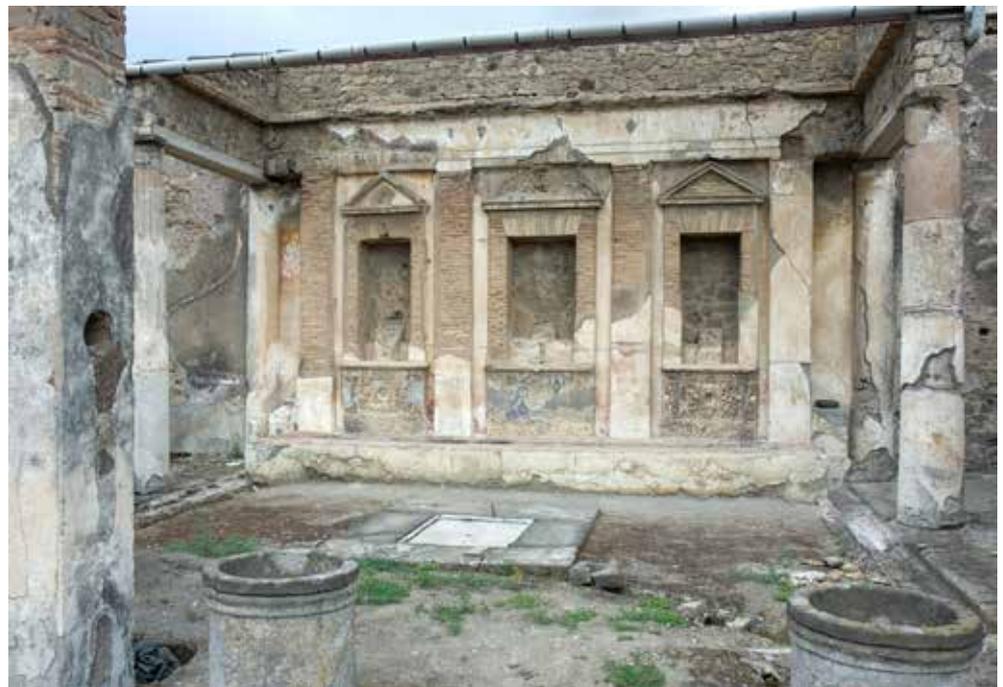
Fig. 41. Nymphaeum of the House of the Bronze Bull (V1,7b). Photograph: Hans Thorwid.

However, it is also worth noting that the latest repair of the painted decorations of the *nymphaeum* wall (of its marble painted half columns) is of remarkably low quality for such a lavish monument.⁹⁵ All these factors contribute to the suggestion that both expansion and regression were in play during the last decades of Pompeian city-life.
