Opuscula

The stadion of Labraunda

The stadion of Labraunda is situated south-west of the sanctuary, above the Sacred Way down to Mylasa. As the terrain is not well suited for a stadion the ends had to be elongated by the addition of built-up ‘towers’; nevertheless the racecourse was rather short at 172 metres. It is situated on a slight slope, and in the middle of the northern side there are cuttings in the rock that may have been used for spectators; otherwise there are no provisions for such. There is a line of starting blocks at either end, more or less in their original place, although few of the blocks are exactly *in situ* and some of them are missing. They are large blocks and have one single continuous groove for the toes of the runner and square holes that separate the lanes. Evidently the number of lanes was 14, and each line was 1.38 m wide. There is nothing that can give an exact date of the establishment, but the outline of the wall structure as well as the historical evidence suggest the Hecatomnid period and the festival programme of Mausolus in the middle of the 4th century BC.

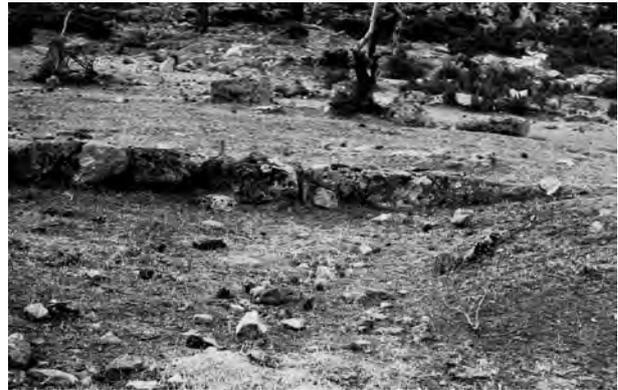
Fig. 5. The racecourse from the south.

On the northern side the field is divided from the surrounding ground only near the western end, where the field is higher; on the southern side a part of the centre of the border is marked by a line of big stones (Fig. 5).

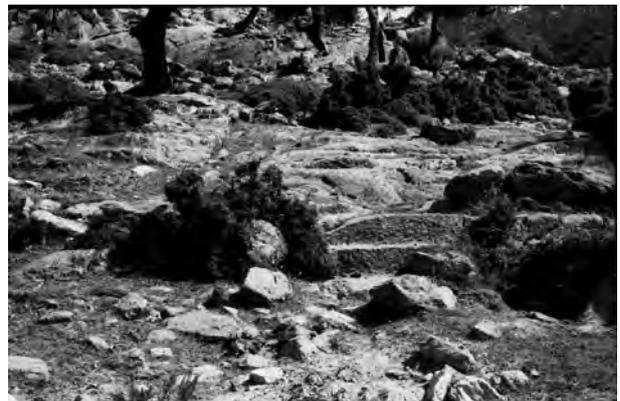
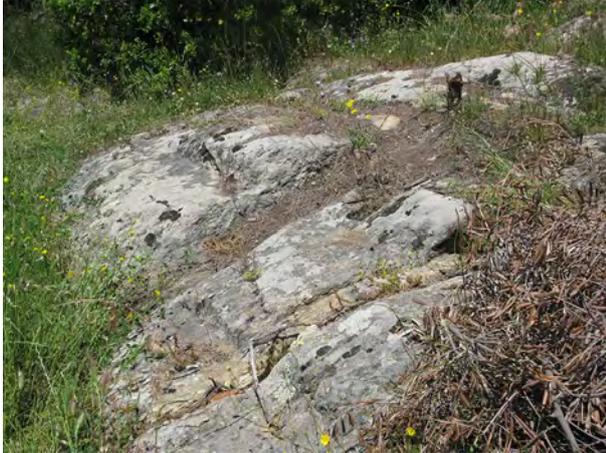
Fig. 6. Cuttings along the slope from the south.

Fig. 7. Cuttings along the slope from the east.

In Labraunda there is a sloping rock on the middle of the northern side, where ledges have been cut as for spectators (Figs. 6–7). About a dozen ledges can be counted, about 0.20–0.25 m high and about twice as wide.¹⁴ Their original extent is not clear but they may be observed for a length of 27 m at the most. It may be noted that there is a space of 14 m between the lowest preserved ledge and the blocks marking the north side of the racecourse.

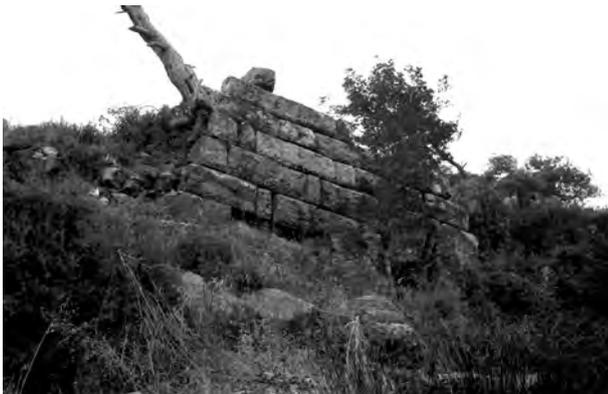
Fig. 11. The eastern wall of the east tower from SE.

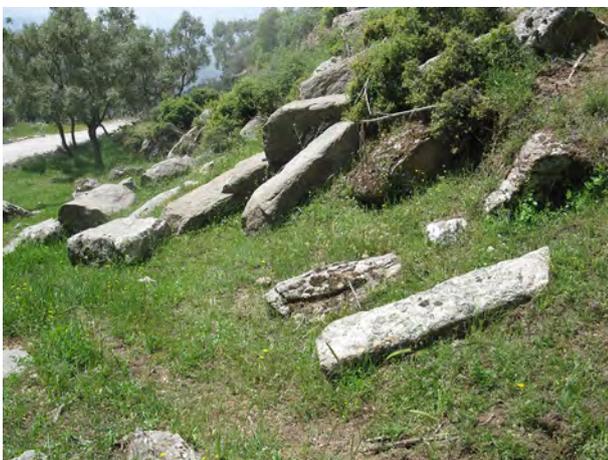
Fig. 12. Blocks below the east wall.

The remains of the eastern end of the stadion hardly deserve the denomination tower compared with the west tower (Fig. 8). Of its northern side nothing is visible (Fig. 47), and the southern side is hardly more than a single line of rather irregular blocks (Fig. 9). Only on the eastern side part of a wall is preserved (Figs. 9–11). Its length is about 8 m, rather less than half of what the original length can be supposed to have been. It reaches about 2.50 m from the original south-eastern corner. It consists of isodomic ashlar blocks with a maximum height of seven courses. The courses are about 0.50 m high and consist of headers and stretchers, with a considerable variation in size. Some of the stretchers are two m or even more, whereas the headers measure only 0.40 m or less. Many blocks are lying on the ground below the wall, especially near the corner (Fig. 12). Some of them measure 2 x 0.50 x 0.56 m or even more.

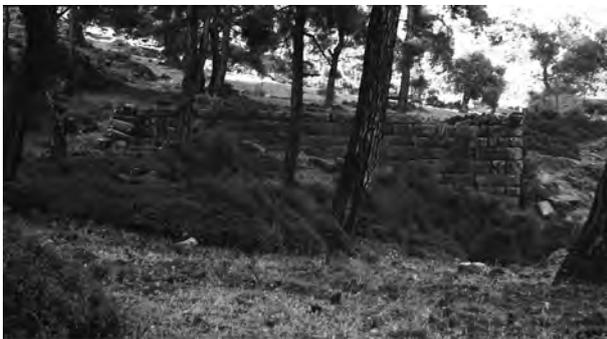
Fig. 15. The west tower from the west.

The west tower is well preserved in most parts, and the western side displays a complete width of 19.30 m (Figs. 15 and 20). Only a few blocks are missing near the south-west corner. Some blocks are lying west of the tower, but their original position is uncertain (Fig. 13). The wall consists of isodomic ashlar blocks with a height of about 0.60 m. The pattern is headers and stretchers, the headers being remarkably narrow, most of them much less than 0.50 m. The stretchers vary in length from 1.50 to 2.50 m. Since the ground west of the tower slopes there is a considerable difference of the visible height of the ends: in the northern end only four courses are visible, whereas in the south corner no fewer than nine courses can be seen (Fig. 14). Some blocks on the ground below the wall may have belonged to a parapet as shown on Joneborg's plan (see Fig. 2).

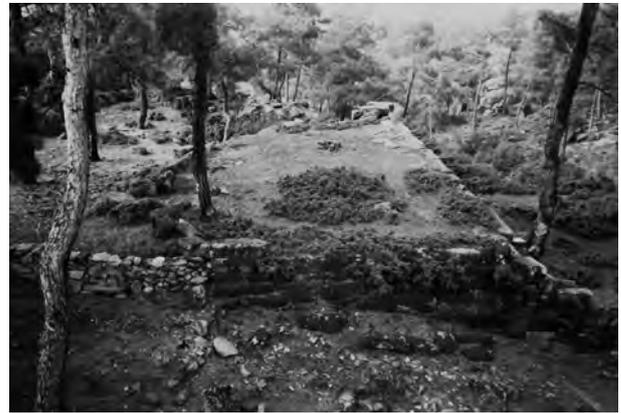
Fig. 16. The west tower from the north.

On the northern side the north-east corner is not much higher than the ground outside it, but the ground level descends along its length, so that to the west the height is a few courses more (Figs. 16 and 22). The structure consists of isodomic

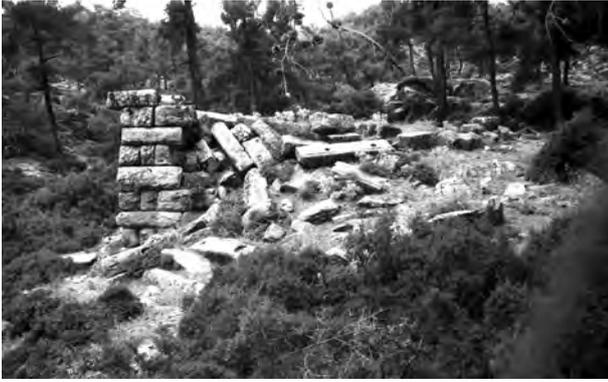
Fig. 18. The west tower from the south. In the centre some of the starting blocks are visible.

Of the south side only the west corner is preserved to a width of one stretcher's length, about 2 m (Figs. 17–18). Only at the bottom the length of two stretchers can be measured. The height is the same nine courses as the west side. The header ends are two side by side, meaning that there are double stretchers on the west side, and in the same way two header ends can be seen side by side on the western side.¹⁶ The corner block at the top has been moved towards the west.

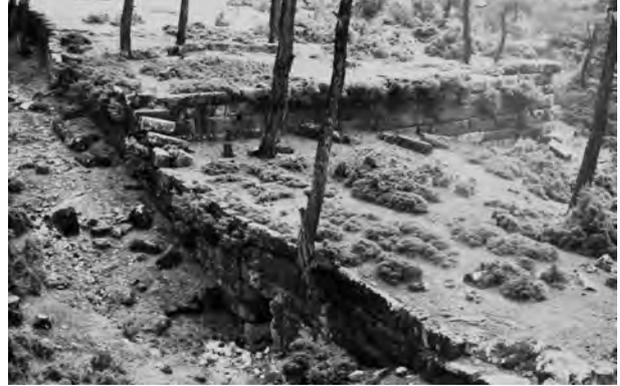
Fig. 20. The west tower and the köprü from NW.

ashlar masonry with not quite regular courses of barely 0.50 m in height, four in the east and six in the west. The longest stretchers are 2 m long but most are much shorter; of headers there are few. The blocks continue into the north face of the *köprü* (Fig. 21). It may be noted that there is an almost 2 m long block to the left on the topmost course as if it had been part of a parapet, and there are some similar blocks on the ground below the wall that might indeed have belonged to a parapet (Fig. 20).

In the eastern part of the *köprü* there are some big blocks, the biggest one measuring 1.80 x 0.50 x 0.45 m on the surface less than 2 m from the wall of the tower (Fig. 20). They may be part of a possible parapet.

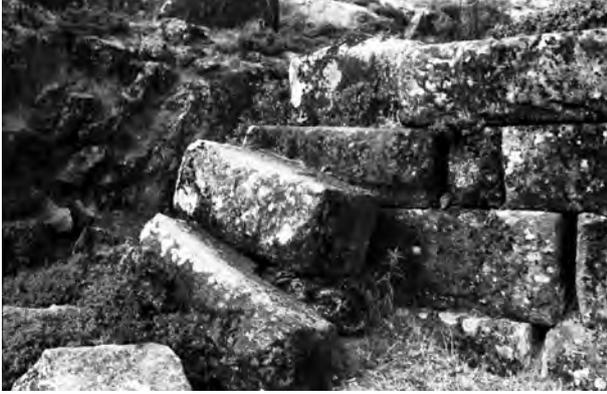
Fig. 22. Irregular steps leading from the west tower to the köprü.

A strange feature is formed by a number of blocks around the west tower. They are ashlar blocks with a half-moon-shaped cutting in one long side, about 0.35 m long and 0.15 m wide. The depth may reach the whole thickness of the block or only part of it. The blocks in question are found among the blocks forming the eastern and southern sides of the west tower (Fig. 45) and are marked with a C on the plan (Fig. 13). Five of them can be counted, some of them long blocks, others considerably shorter. It is noteworthy that one of them forms the second step of the secondary staircase in the NW corner of the tower, a block, the original position of which is unknown (Fig. 22). What the purpose of these cuttings may have been I do not know.

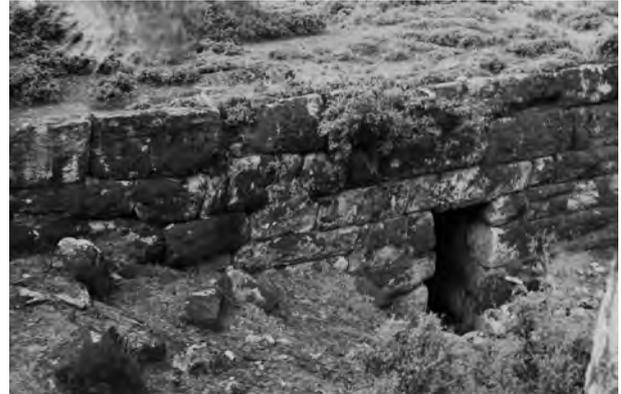
Fig. 24. The north tunnel opening.

The northern side forms a continuation of the north side of the west tower, built of big ashlar blocks, some of them 0.75 m high (Fig. 23). Few of them can be reckoned as headers. The maximum number of courses is seven at the tunnel opening, which has its bottom 4.65 m below the top of the *köprü* (Fig. 24).

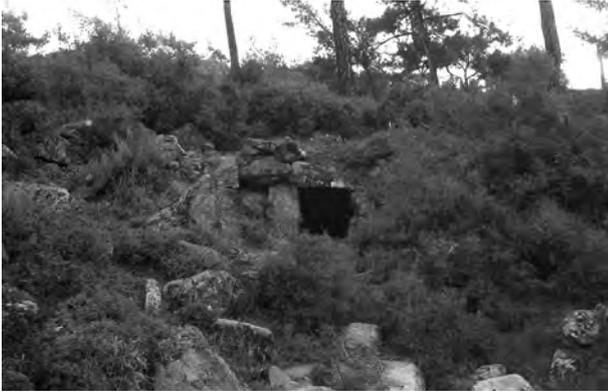
Fig. 25 and 26. The south tunnel opening (above and below).

The maximum number of courses is five at the northern end, whereas there are only three courses at the southern end. There is no significant difference between the two sides of the tunnel (Figs. 26–27). The roof consists of large, wide blocks, the height of which is difficult to report. As a rule they are laid on top of the wall blocks, but the lintel blocks in both openings are cut to be inserted into the wall blocks (Figs. 27–28), and this might be true also for some other blocks where this detail could not be observed.

north side and another 0.90 m lower on the south side, and consists of rough earth. The top is 2.10 m below the *köprü* on the north side and about 2 m lower on the south side; however, its ceiling is not sloping but is lowered stepwise in three offsets (Figs. 26–27). The height is 2.60 m at the north end but only 1.45 m at the south. The width is about 1.10 m. The southern end is marked by an east jamb consisting of blocks about 0.40 m wide and a west jamb consisting of blocks about 0.55 m wide, continued by some irregular blocks (Fig. 26).

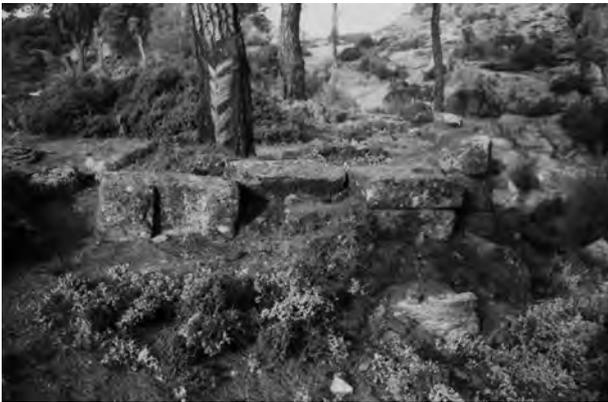
Fig. 33. The west tower, northern part from the east with blocks W1-2 and S.

Near the south end of block W2 is a block, marked S on the plan (visible on Fig. 33). It lies in a NW-SE alignment and is probably approximately *in situ*. It is 1.25 m long, c. 0.56 m wide and 0.60 m high, but it is rather rough, at least compared with the starting blocks. Its NE side has a roughly rectangular but irregular cutting through its whole height, 0.47 m wide and 0.08 m deep. It is not placed symmetrically to the block but nearer its NW end, 0.29 m. Its exact purpose is unknown, but there are similar blocks in the same position in front of the starting line in other stadia. Evidently they have some connection with starting devices. A check on other stadia shows that varying and much more complicated devices exist in association with other starting lines.³¹ They are supposed to connect with a starting device, a *hysplex*, and probably this much simpler block

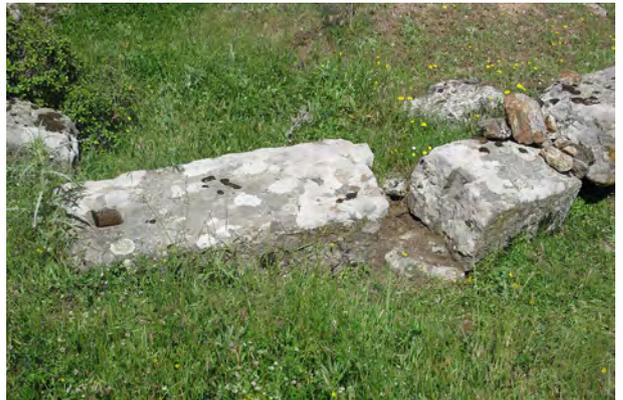
Fig. 37. The two pieces of starting block E5 from the east.

E5 (*Fig. 37*) 2.33 – 0.59 – 0.38 together, broken into two parts through the northern hole. N-S and NE-SW direction, face upwards. Groove and two holes, 0.16 from the south and 0.65 from the north.

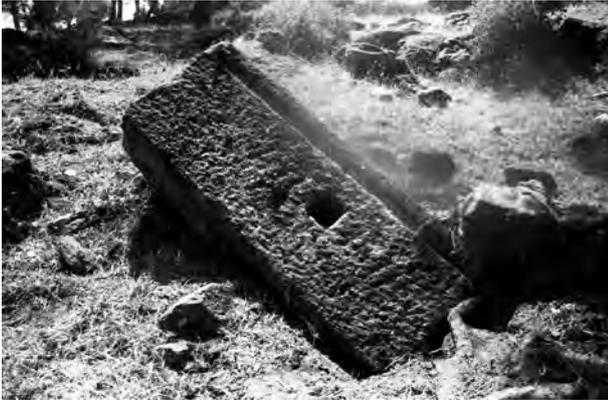
Fig. 38. Starting block E7 from the east.

E7 (*Fig. 38*) 1.68 – 0.62 – 0.41, broken at the northern end. N-S direction, face obliquely upwards with the northern end in the ground. Groove and one hole, 0.95 from the south.

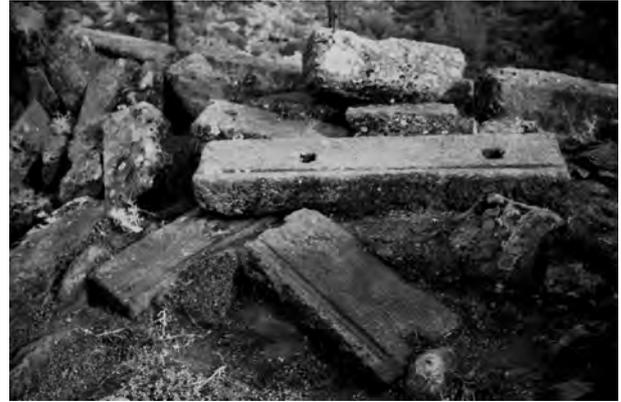
Fig. 41. Starting block W8 from the south with W9 under it and W7 in front.

whereas those to the south have rolled down towards the south with the collapse of the southern wall (Fig. 41). Those in the middle of the western line are certainly not far from their original position but have been moved in a quite unaccountable way, and it is far from certain what position in the line every single block had or how many of them are missing, a difficulty enhanced by the existence of fragments off-line, see below.

W7 (Fig. 41) 1.45 – 0.64 – 0.34. NW-SE direction, face upwards, slightly towards S. Groove and two holes, reaching exactly to the ends of the block, which is broken at the north end.

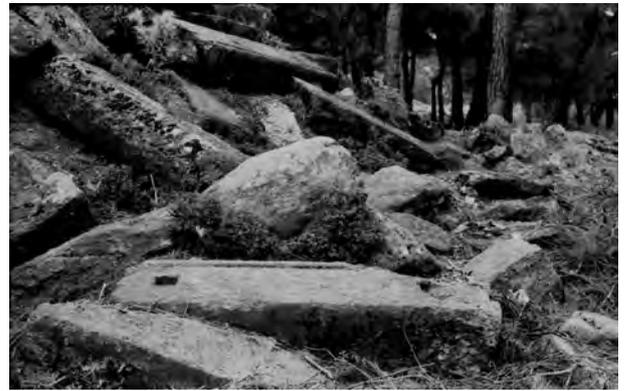
Fig. 42. Starting block W10 from SW.

W10 (Fig. 42) 1.99 – 0.61 – 0.37. NW-SE direction, face upwards, slightly towards SW. Circular hole, 0.41 in diameter, 0.03 from the front and immediately at the end, 0.02–0.08 deep. Groove and one hole, 0.19 from the north. How far towards the south the groove continues cannot be ascertained, since the surface is considerably defaced or damaged at the southern end; the depth of the circular hole sinks to 0.02 at the end.

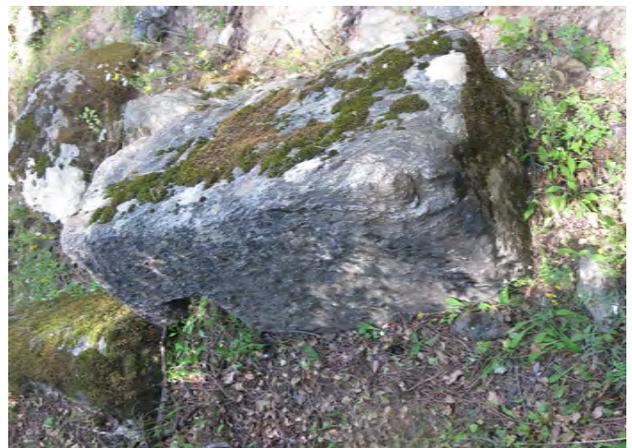
Fig. 43. Block X from the north.

X. A broken block situated north of the northern end of the western starting blocks, just outside the racecourse and at a lower level (*Fig. 43*).²⁹ Its pres. L. is 0.76, pres. W. 0.40, and its H. 0.38. Its left side surface is intact, its upper surface intact and smooth, its back side intact and rough, its right and front sides are broken. No groove is visible, but it ought to have been exactly in line with the break. A square hole, 0.12 x 0.12 is situated exactly at the front edge, 0.56 from the left and 0.21 from the back. Its depth is probably 0.17, but the stone is broken at this place, and the hole goes straight through it.

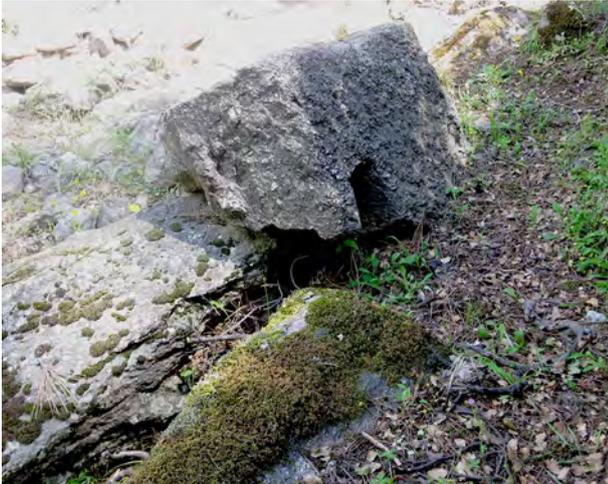
Fig. 44. Block Y from SW.

Y. Another broken block also situated north of the northern end of the western starting blocks at the same level as block X, about 3 m east of it and near starting block W1 (*Fig. 44*). It measures 0.40 x 0.40 and has an intact short end and a very

irregularly broken other end. There is a hole measuring 0.12 x 0.12, situated 0.25 from the short end and the same distance from what was the back side. There is no groove, but the block is damaged where the groove should have been, and perhaps the damage was the reason for the cancelled execution.
